Dilapidation Report

Pre-Construction

PROPERTY: STREET
SUBURB

JOB NUMBER: 222-XXX-XXX

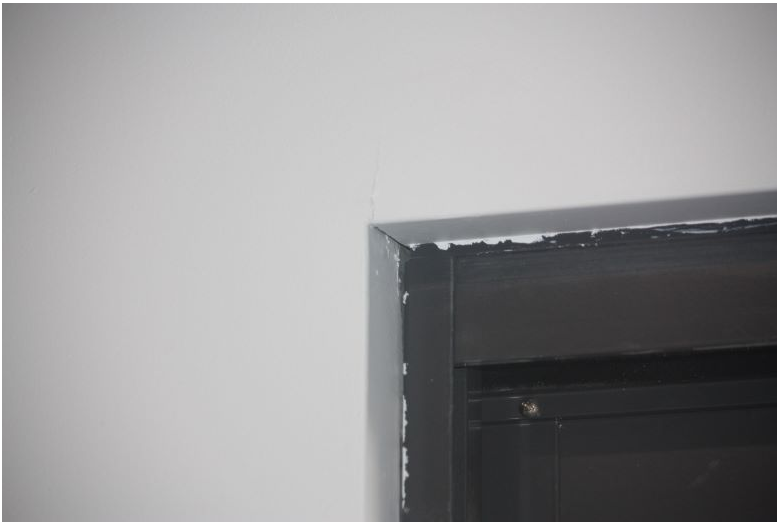
IMG_09981.JPG

**INTERIOR
OFFICE/RECEPTION**

View to wall at top LH corner of sliding door to outside.

Vertical crack in wall running for a height of approx. 20mm, hairline.

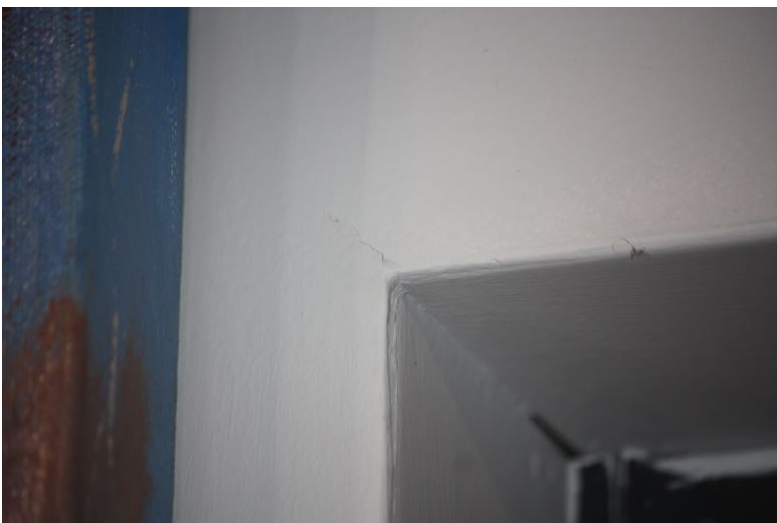
IMG_09982.JPG

View to wall at top LH corner of north most window in west wall.

Diagonals crack in wall running for a length of approx. 10mm, hairline.

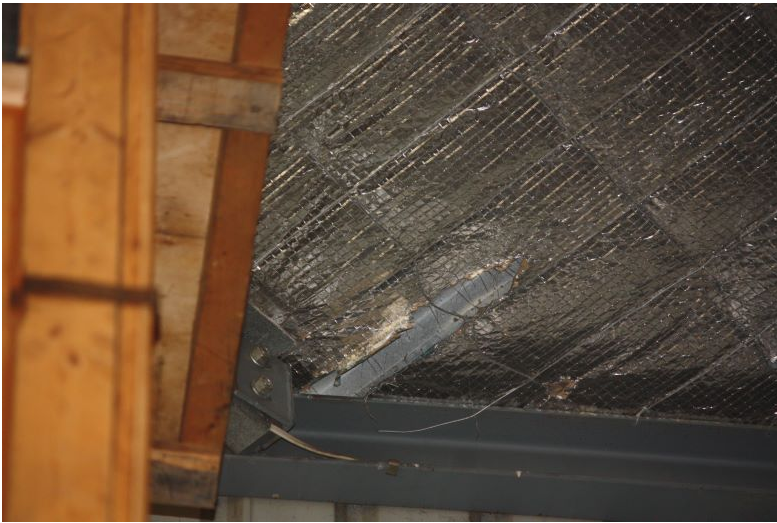
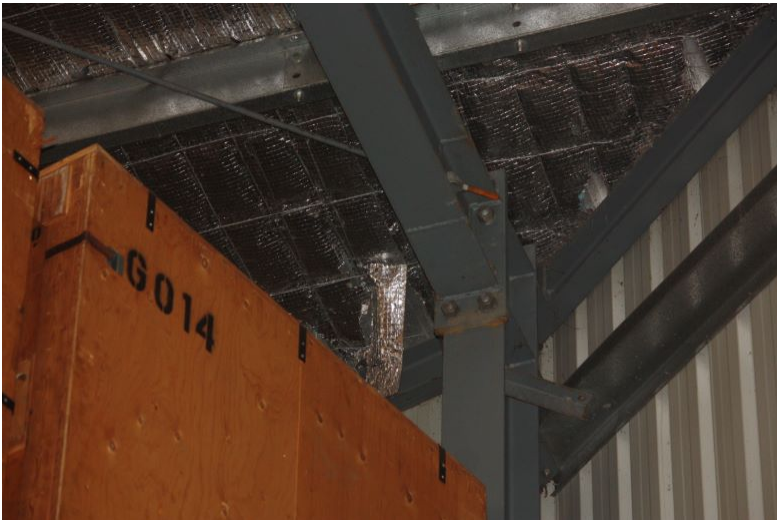
IMG_09983.JPG

EAST FACTORY AREA

View to sarking at SE corner of area.

Visible damage to sarking. Similar occurring elsewhere.

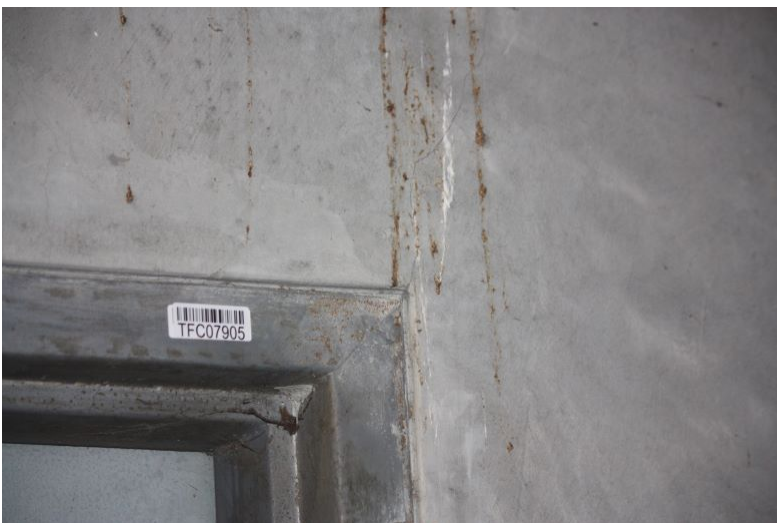
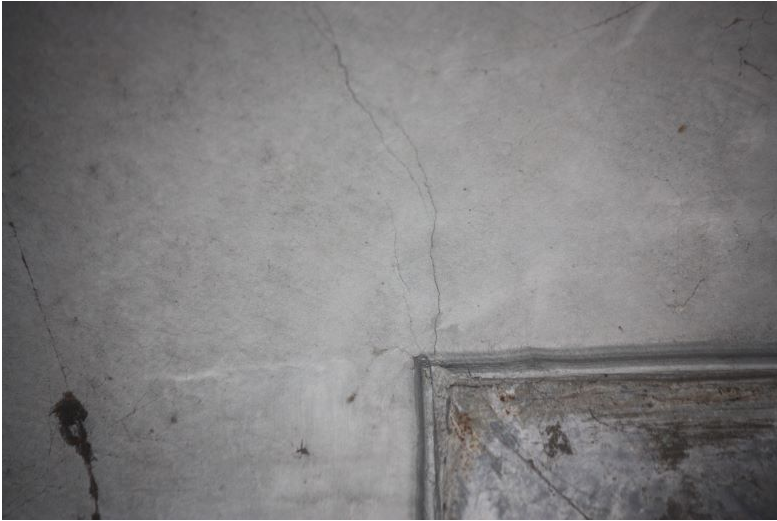
IMG_09985.JPG

View to concrete panel wall at top RH corner of pedestrian door in north wall.

Visible crack running up from top of door to top of concrete panel. Similar occurring at top left of door, hairline.

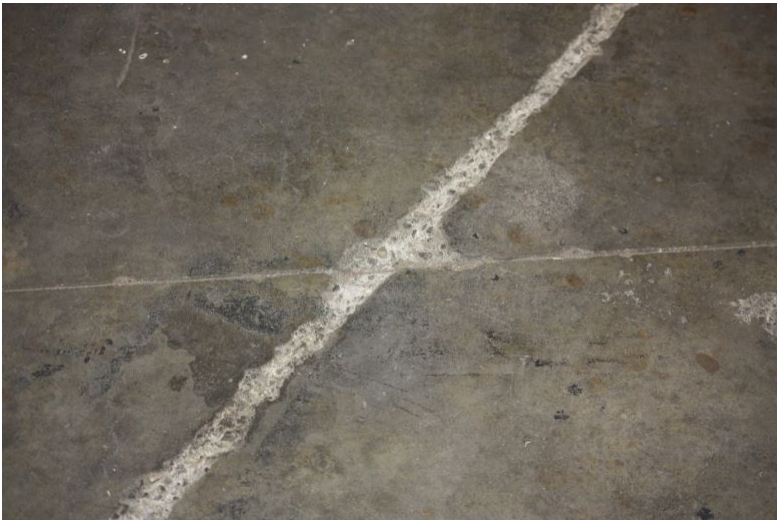
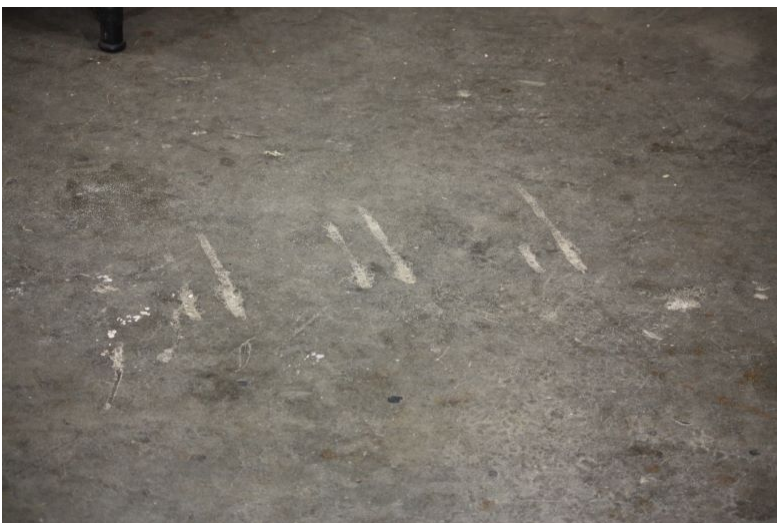
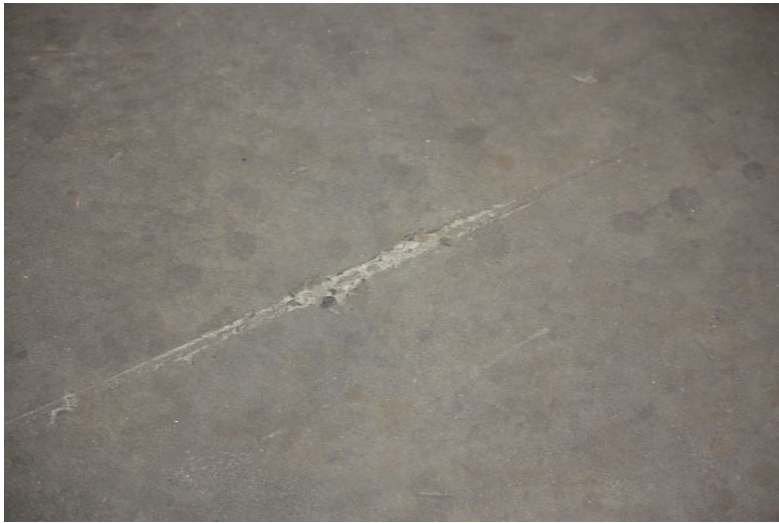
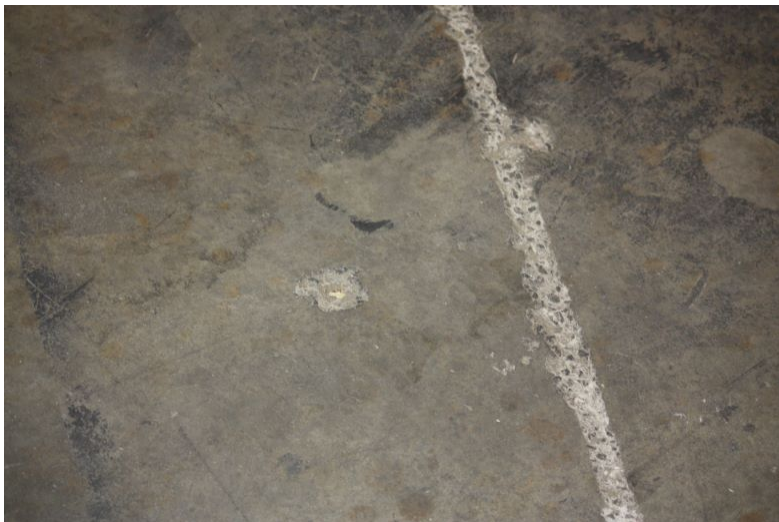
IMG_09987.JPG

View to concrete slab at middle of area.

Visible scuff marks in slab.

Typical.

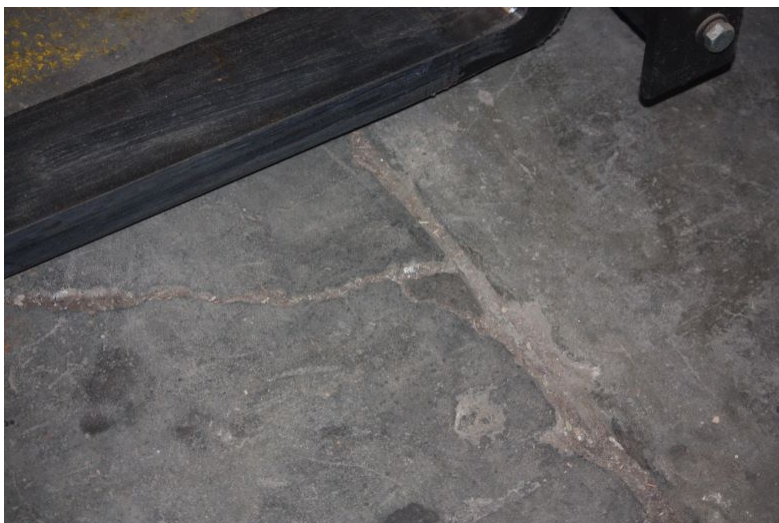
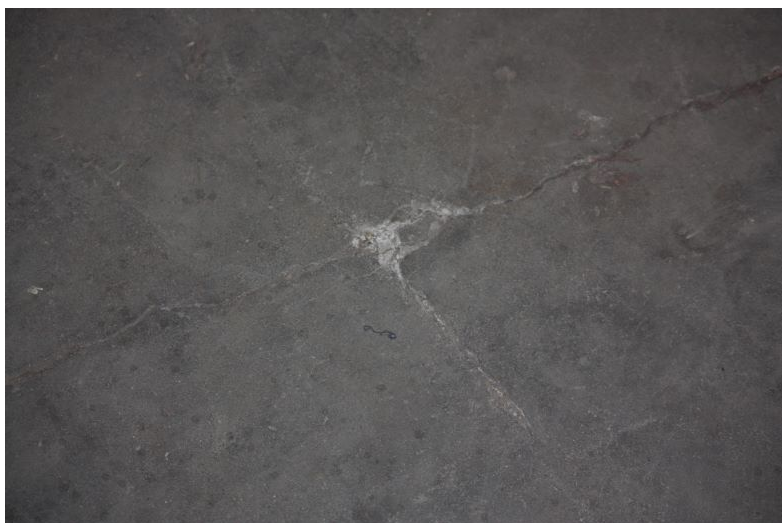
IMG_09991.JPG

WEST FACTORY AREA

View to concrete slab at middle of area.

Cracking in slab running in a SW direction to 5mm.

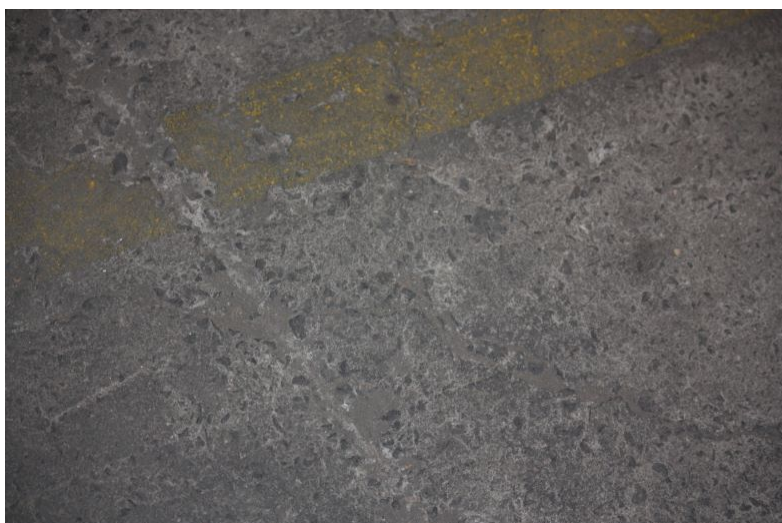
IMG_09993.JPG

View to concrete slab approx. 5 metres west of square opening in east wall.

Visible cracking in slab running in 3 directions, hairline to 3mm.

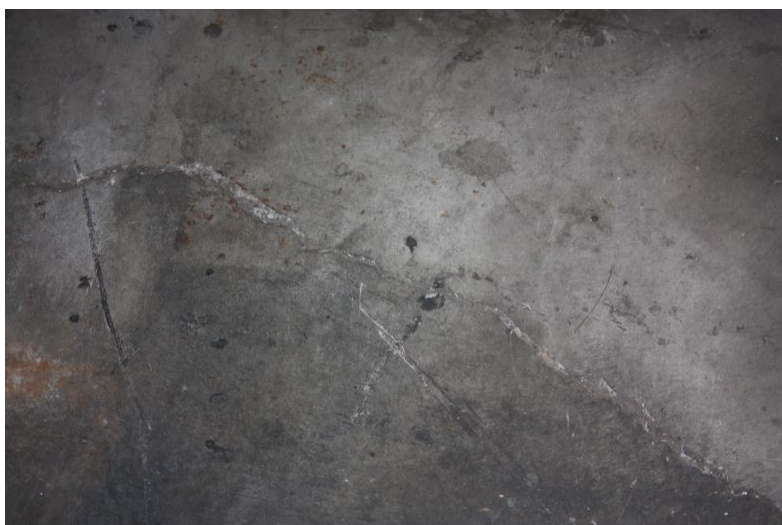
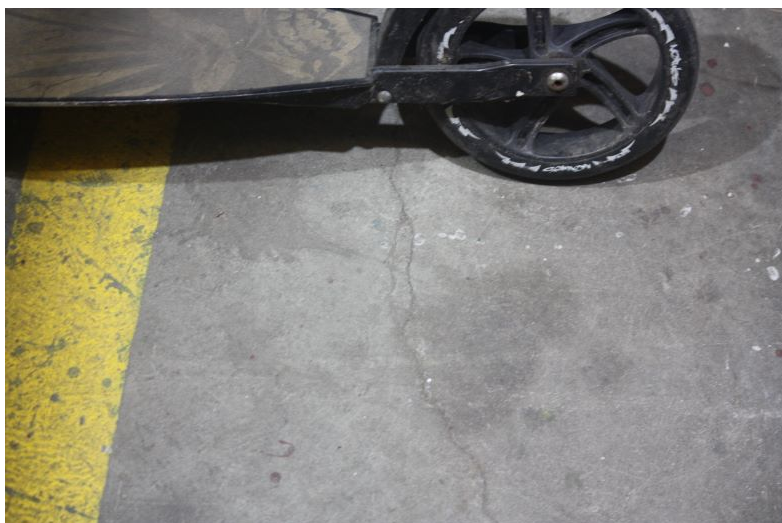
IMG_09994.JPG

View to concrete slab at NW corner of area.

Visible cracking in slab running in a NW SE, hairline to 3mm.

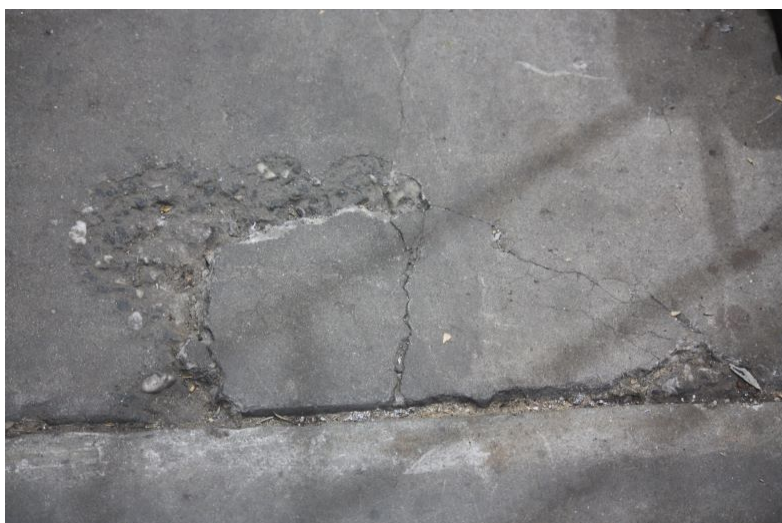
IMG_09996.JPG

View to concrete slab at north side of area.
Visible cracking running in a east direction
with also damage to edge of concrete slab,
hairline to 1mm.

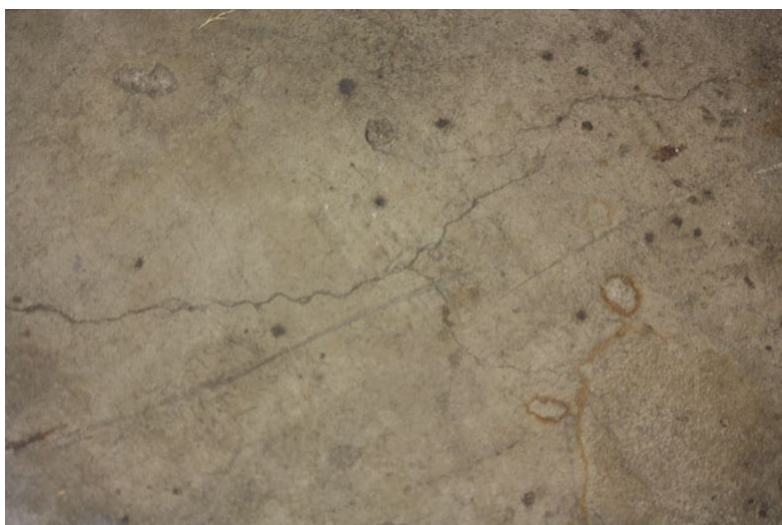
IMG_09997.JPG

KITCHENETTE AREA
View to concrete slab at middle of area.
Cracking of slab running east to west,
hairline to 1mm.

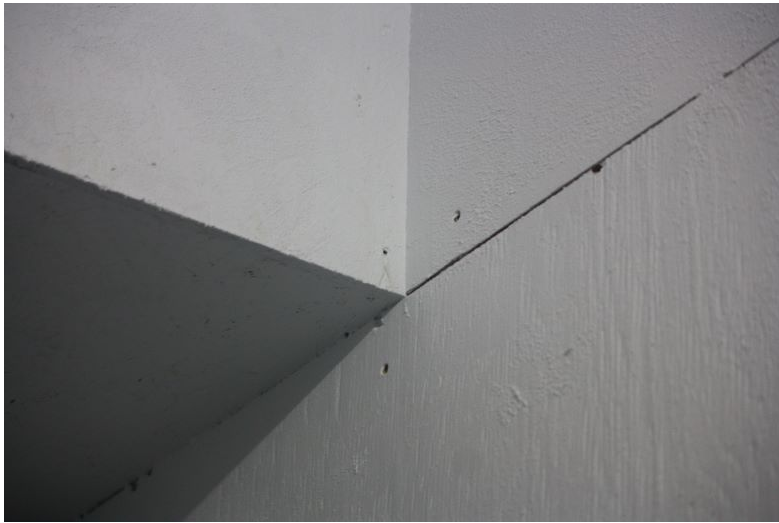
IMG_09998.JPG

WEST TOILET

View to square set cornice at NE corner of area.

Visible separation between wall panelling, 1mm to 2mm maximum.

A number of nail pops also visible, typical to walls.

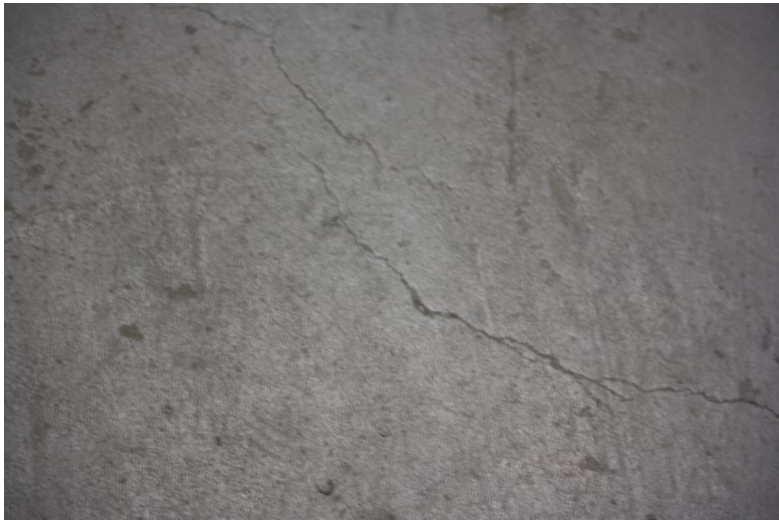
IMG_09999.JPG

View to concrete slab to the south of door to west toilet.

Cracking in slab running full width of room, hairline.

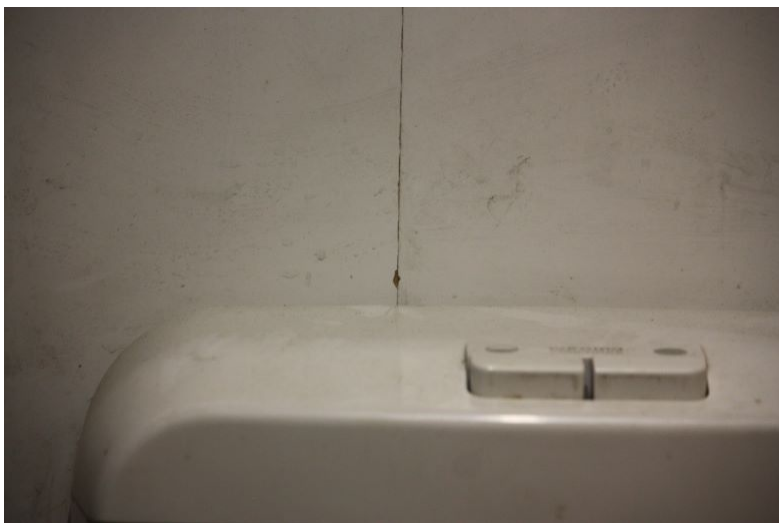
IMG_10001.JPG

EAST TOILET

View to wall panelling above toilet.

Separation between wall panelling, hairline to 1mm. With differential movement to 4mm at top of panelling. Similar occurring elsewhere.

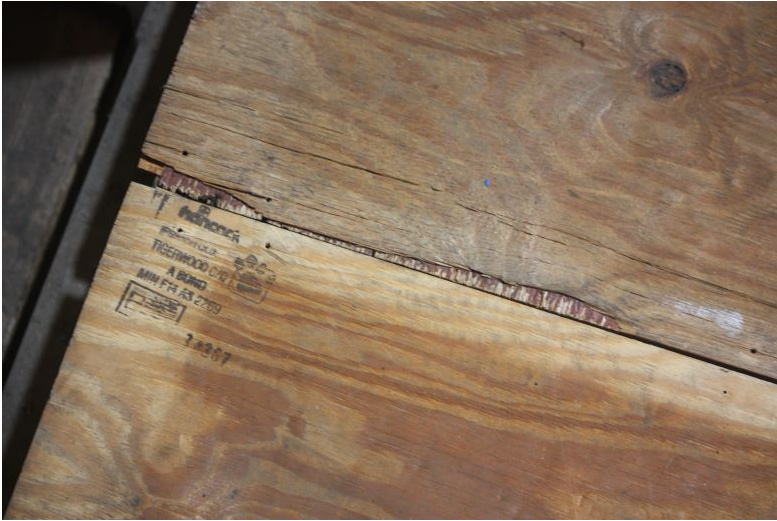
IMG_10002.JPG

MEZZANINE FLOOR

View to flooring at east side of mezzanine.
Visible gap between floor panelling to 5mm.

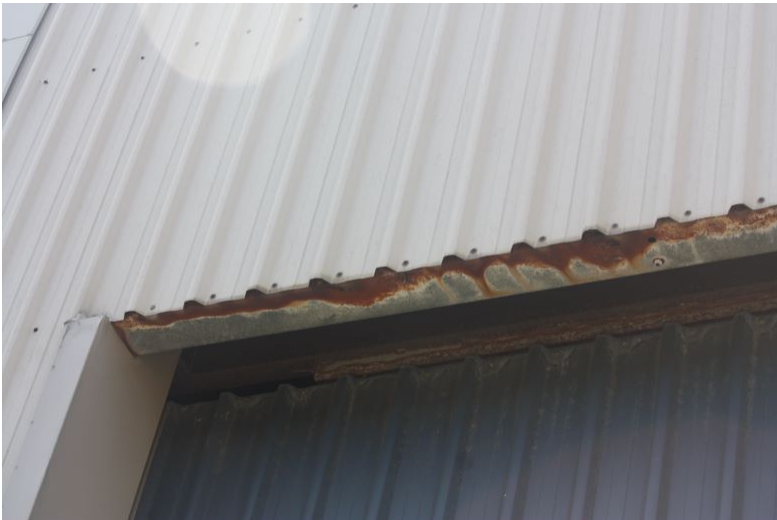
IMG_10003.JPG

EXTERIOR

SOUTH ELEVATION AND SURROUNDS

View to wall cladding at top LH corner of roller door at SW corner of building.
Visible rust to underside of panelling.

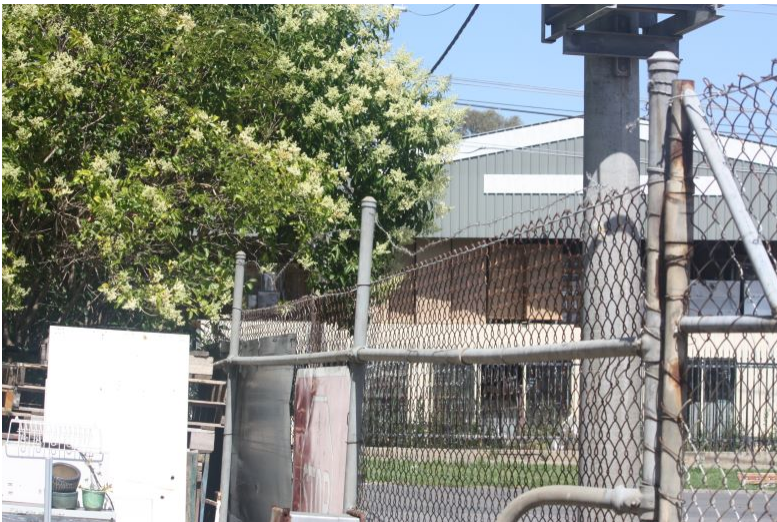
IMG_10004.JPG

View to top of cyclone fencing at middle of south side of property.

Visible barb wire damaged. Mesh ins fence showing rust with areas of damage.
See additional photo.

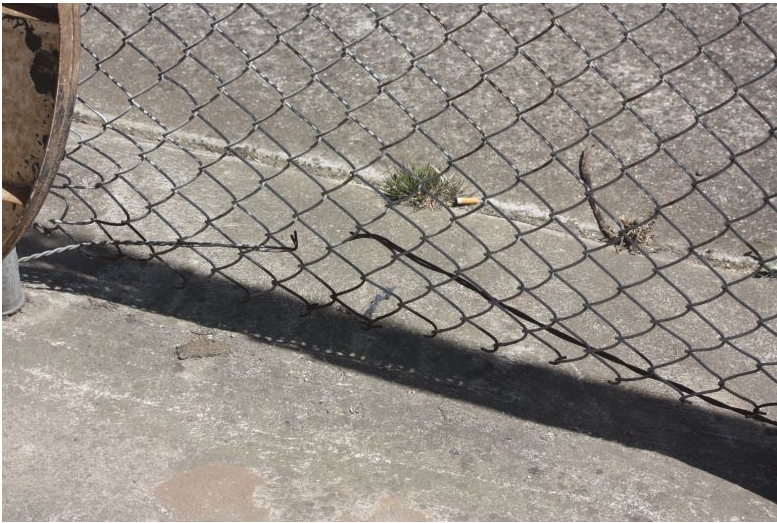
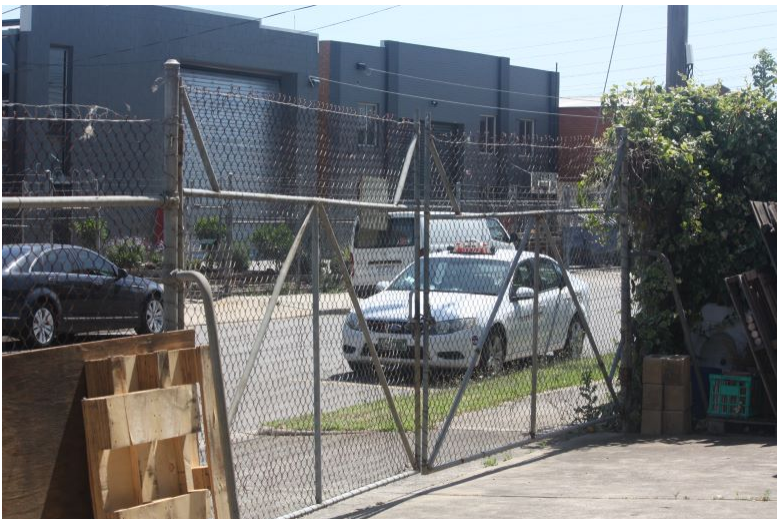
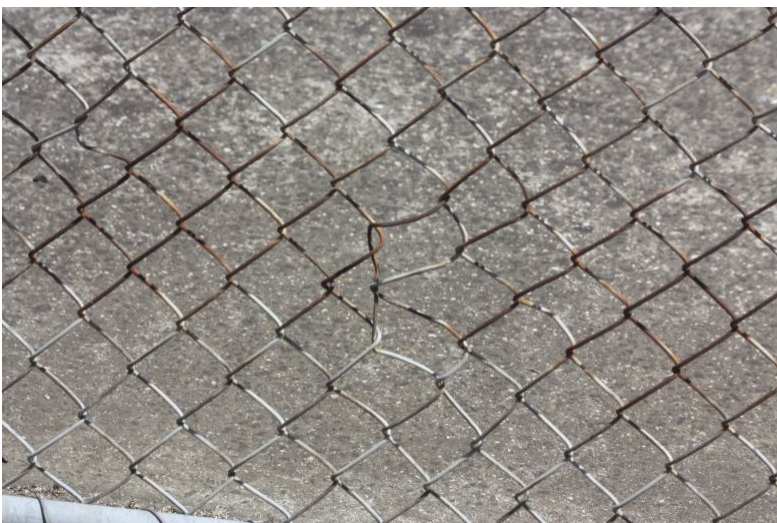
IMG_10006.JPG

View to double gate at SW corner of property.

Gate generally in fair condition. Some areas of damage visible to mesh with rust in areas.

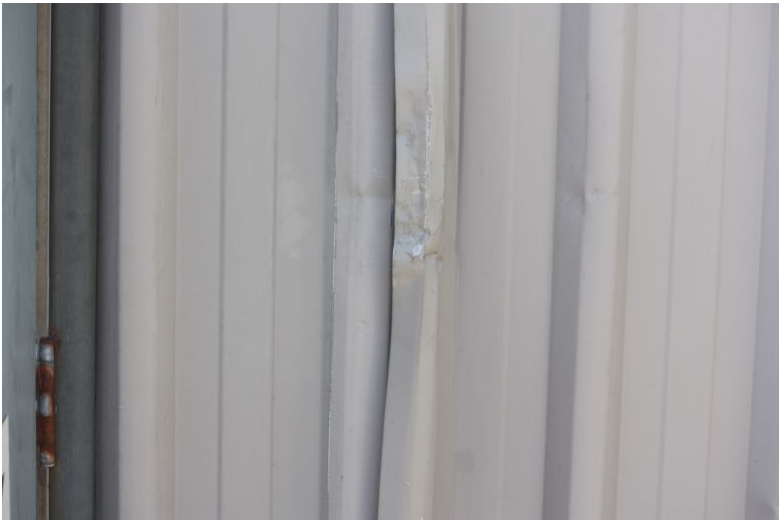
IMG_10009.JPG

View to metal cladding at RH side of pedestrian door in south elevation.

Visible damage to metal cladding, cause unknown.

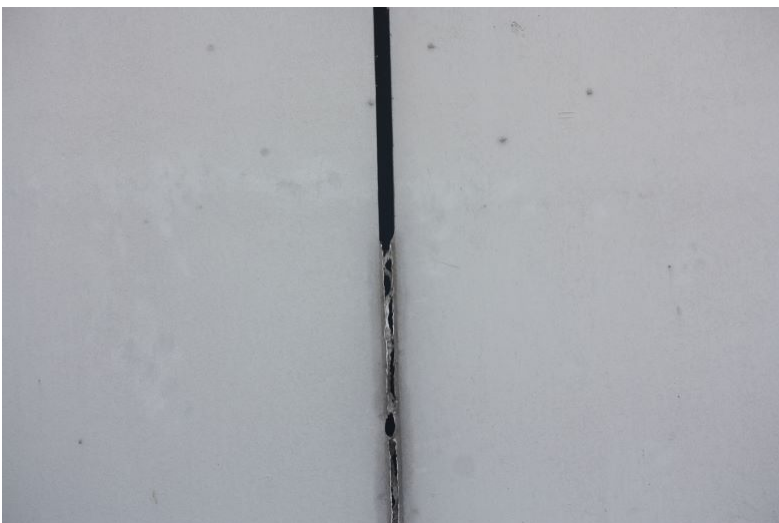
IMG_10010.JPG

EAST ELEVATION AND SURROUNDS

View to top of concrete panel wall at SE corner of property.

Visible cracking to caulking between panels with separation to 15mm at top of panel wall.

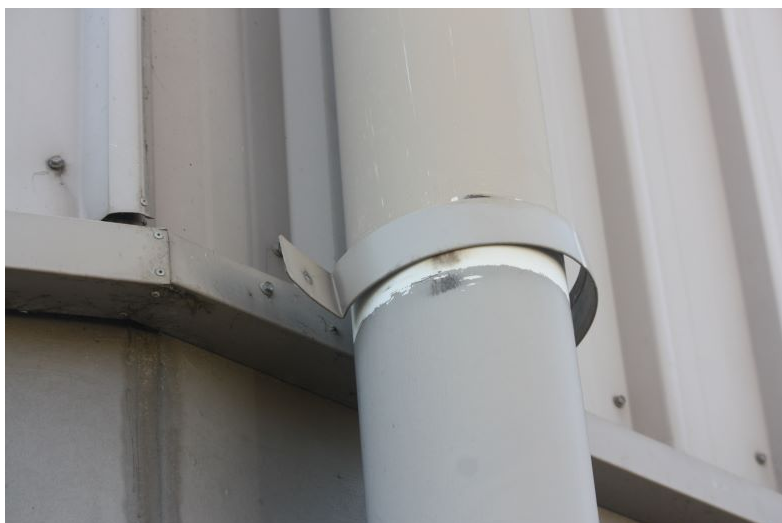
IMG_10011.JPG

View to down pipe at SE corner of property.

Visible connection to down pipe loose.

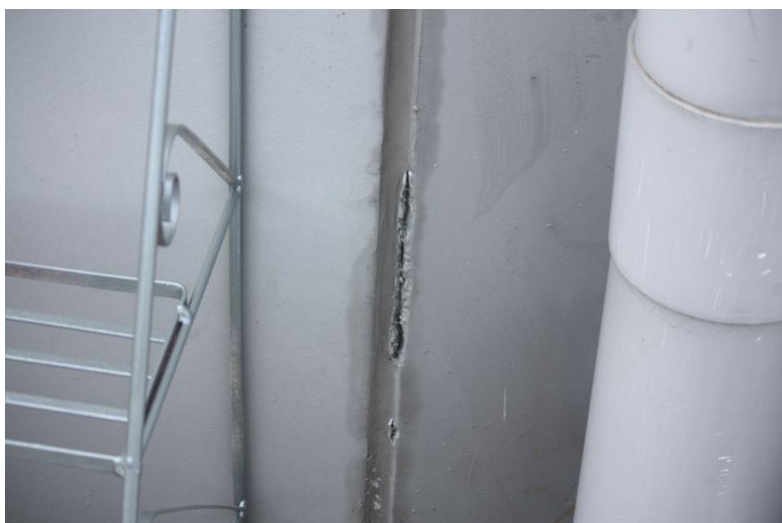
IMG_10012.JPG

View to caulking joint between concrete panels below last.

Visible separation between caulking/concrete panel to 3mm.

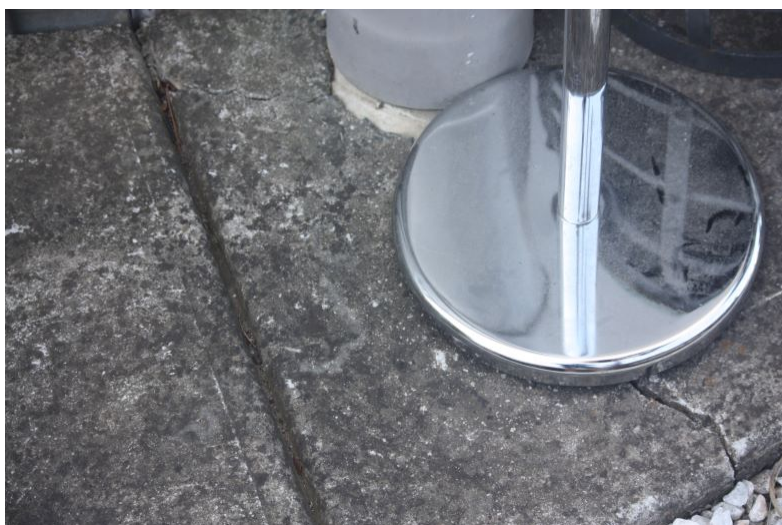
IMG_10013.JPG

View to concrete apron below down pipe at SE corner of property.

Visible cracking in concrete apron, 2mm - 3mm maximum.

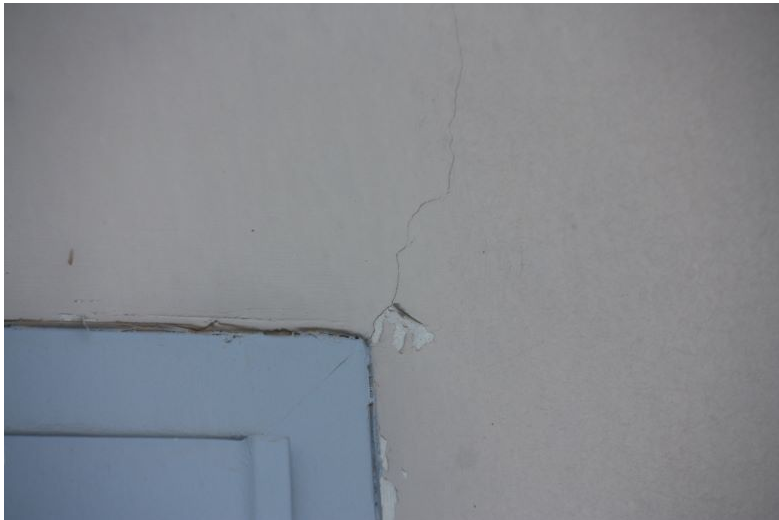
IMG_10014.JPG

View to concrete panel at top RH corner of door to pedestrian door in east elevation.
Vertical crack running from top of door to underside of metal cladding, hairline.

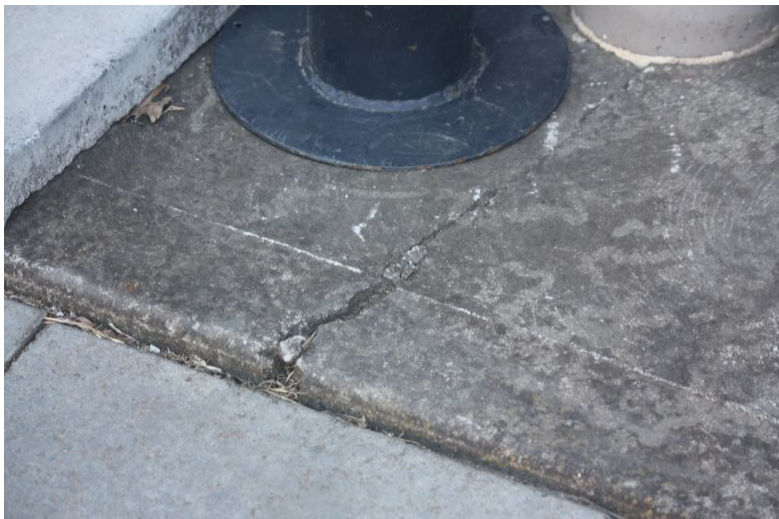
IMG_10015.JPG

View to concrete apron at bottom right corner of pedestrian door.
Visible crack in apron, hairline to 3mm.

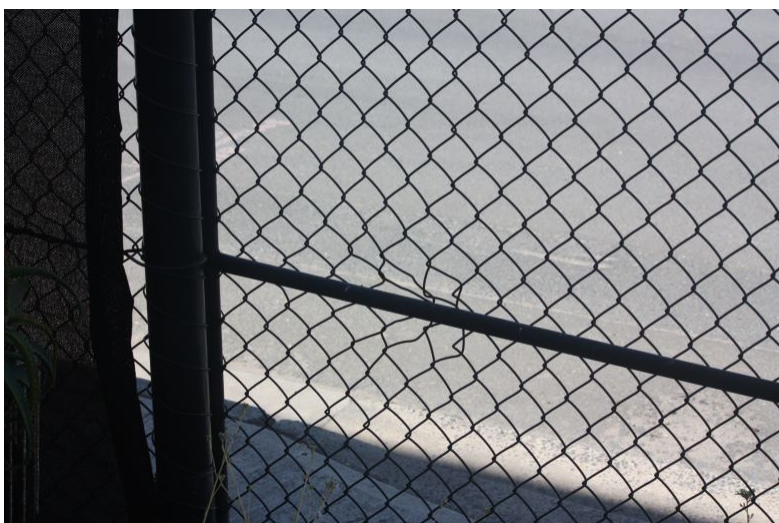
IMG_10016.JPG

View to wire mesh at northern end of double gate at east side of property.
Visible damage to wire meshing. Cause unknown.

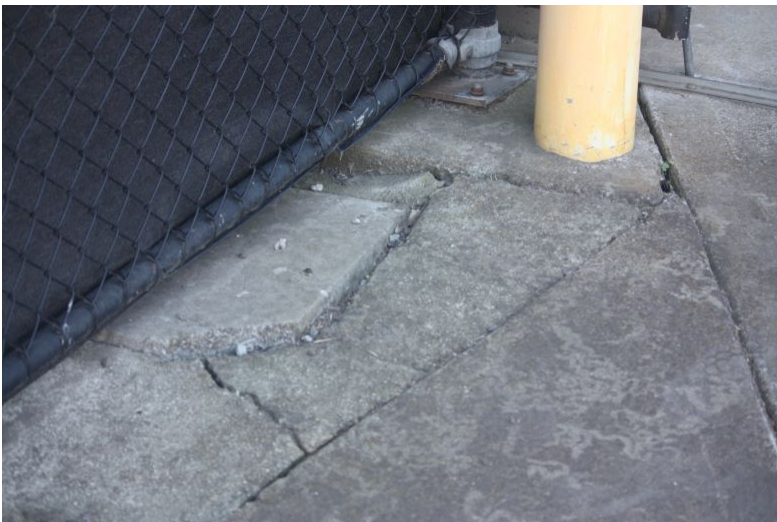
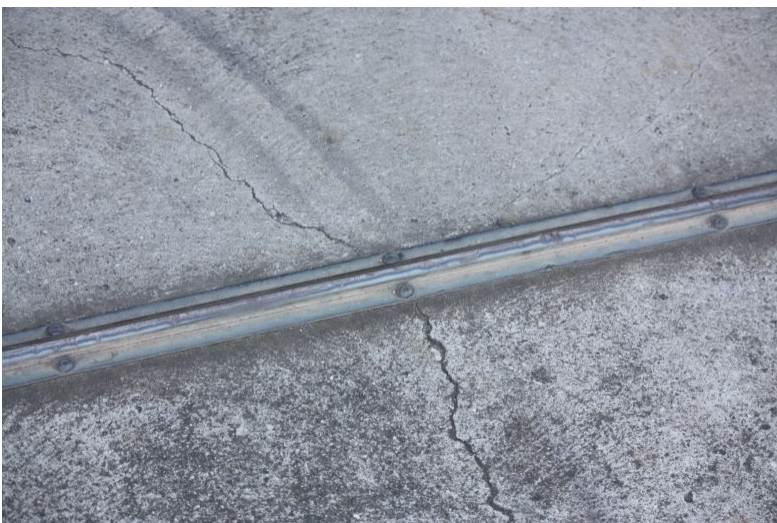
IMG_10020.JPG

View to concrete drive at middle of sliding gate.

Visible cracking running east to west to full width of concrete panel, hairline to 2mm. Cracking also spreads out south. See additional photo.

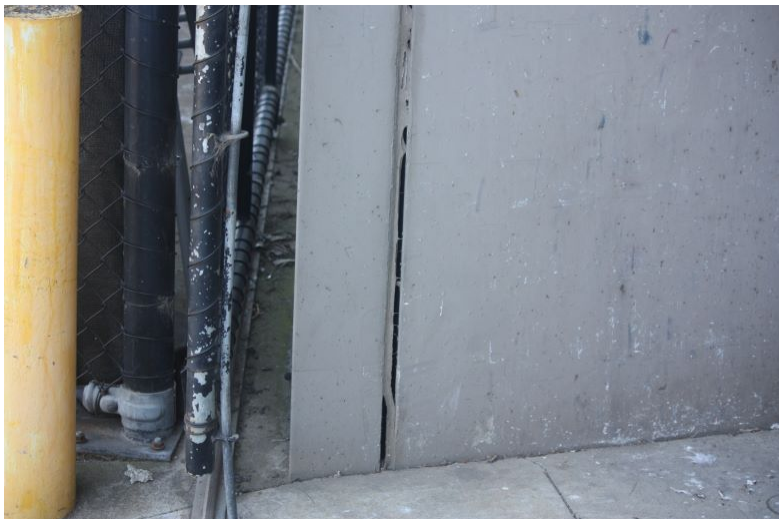
IMG_10022.JPG

View to caulking of joint at NE corner of building.

Visible separation at caulking/panel at 10mm running full height of concrete panel intermittently.

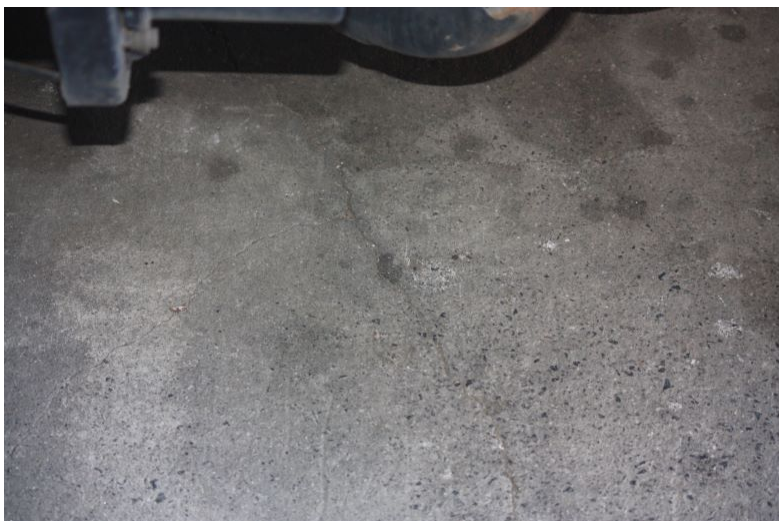
IMG_10023.JPG

View to concrete drive at SE corner of driveway.

Visible cracking in drive running north-south and running out in a NE direction, hairline to 1mm.

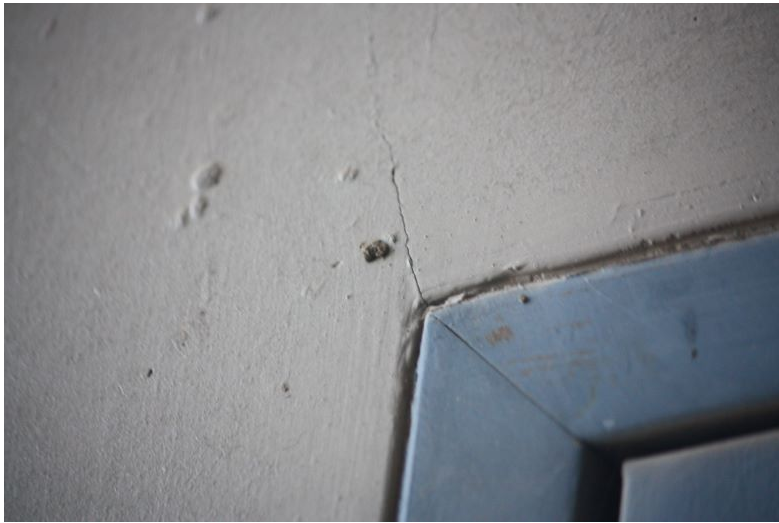
IMG_10024.JPG

View to concrete panel at top LH corner of north pedestrian door.

Cracking running up from top of door frame to underside of metal cladding, hairline.

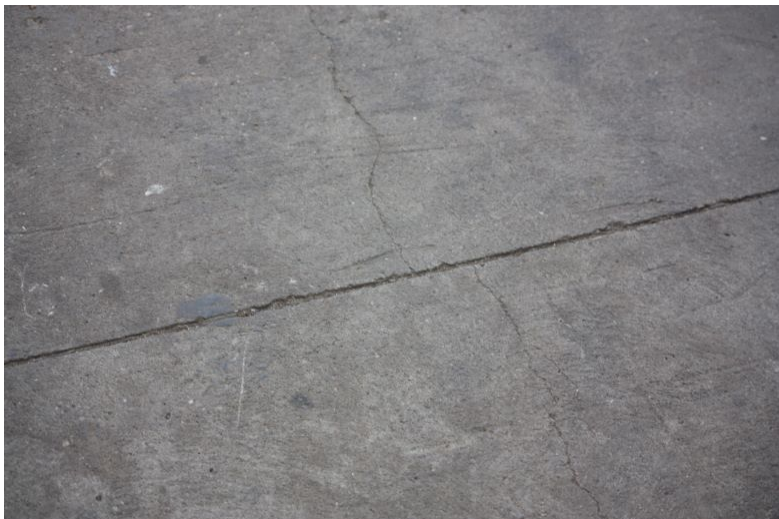
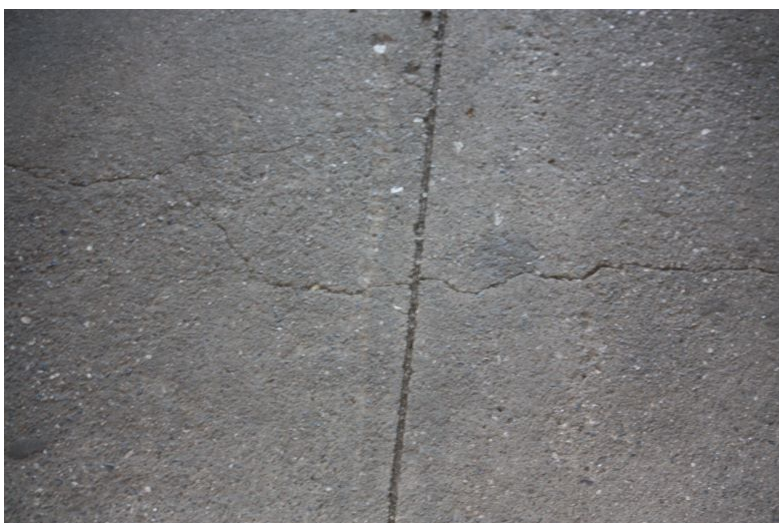
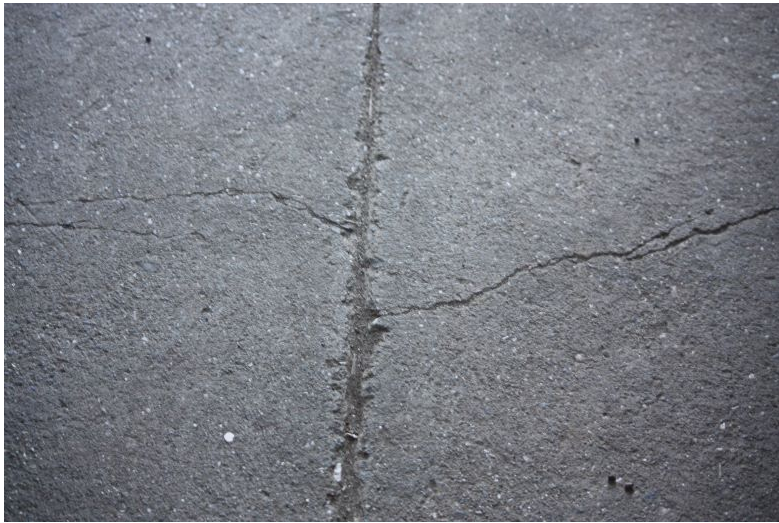
IMG_10025.JPG

View to concrete drive at west side.

Visible cracking running north-south from middle control joint, hairline. Similar occurring elsewhere.

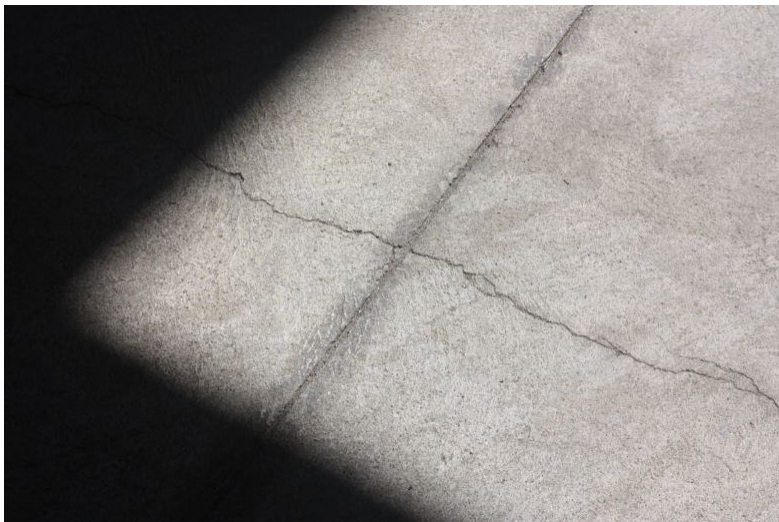
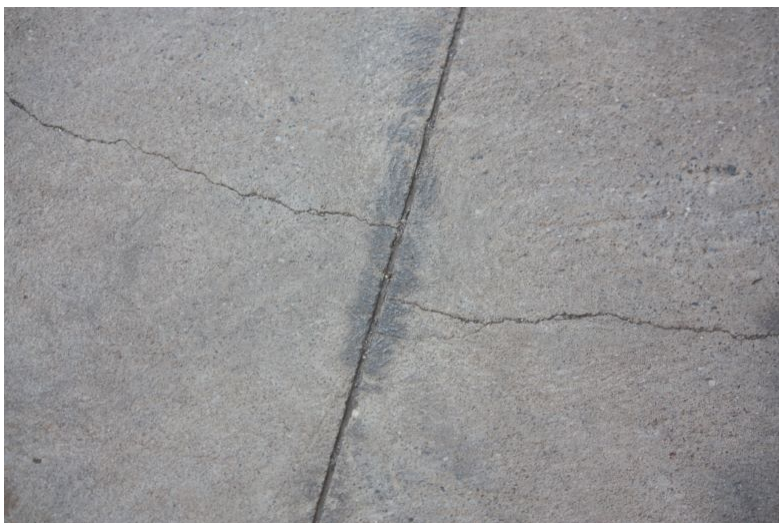
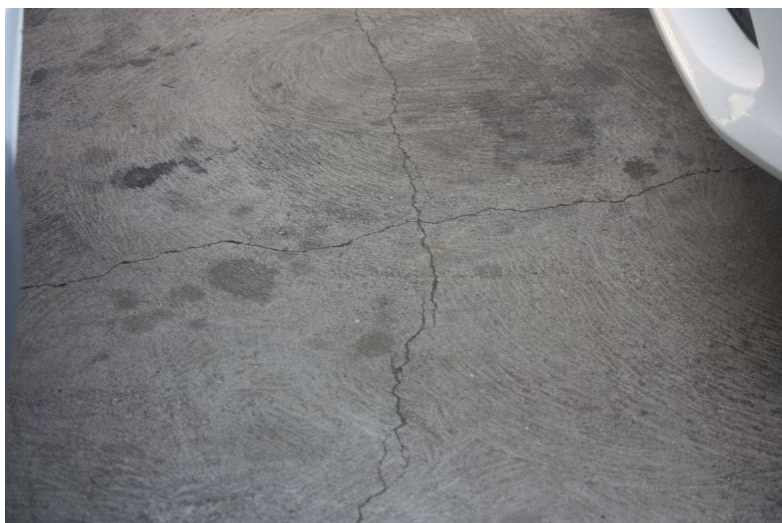
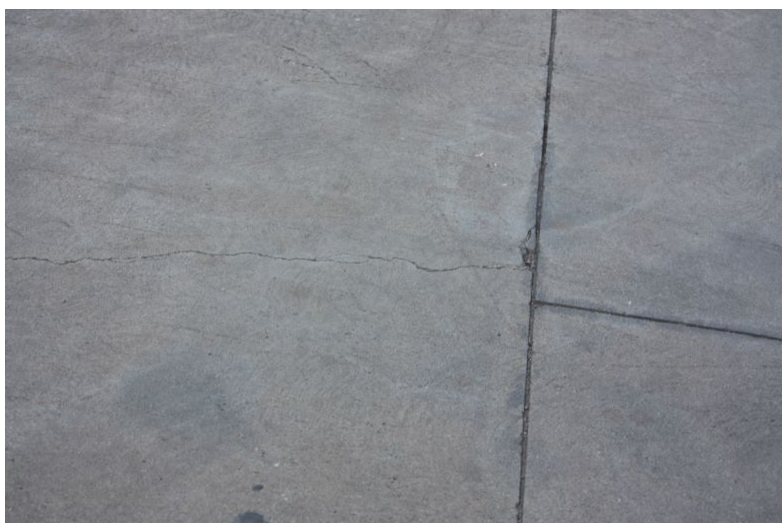
IMG_10028.JPG

View to concrete drive at NW corner of awning.

Cracking in drive running north-south, hairline to 1mm. Similar occurring at east side of driveway also. See additional photos.

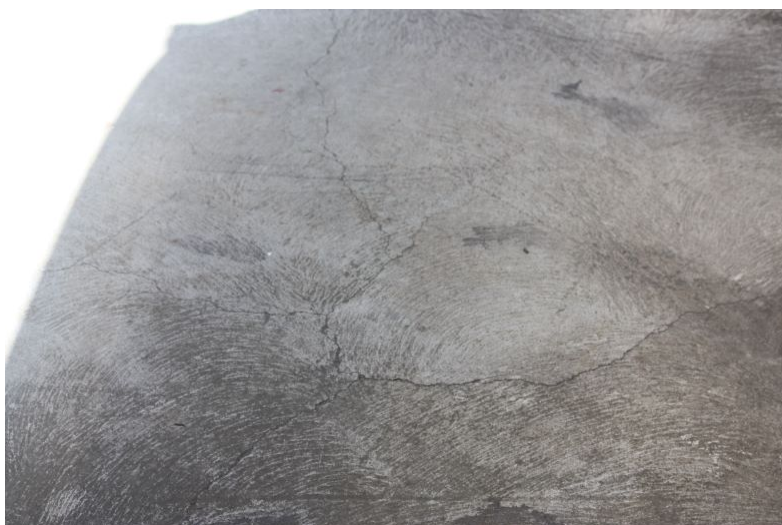
IMG_10032.JPG

View to concrete paving at middle of drive running east-west to full length of property.

Cracking spreading out in all directions, hairline to 1mm.

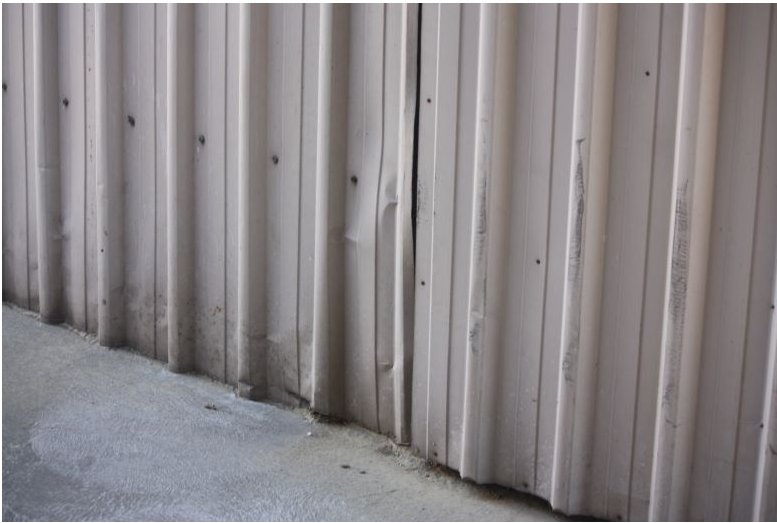
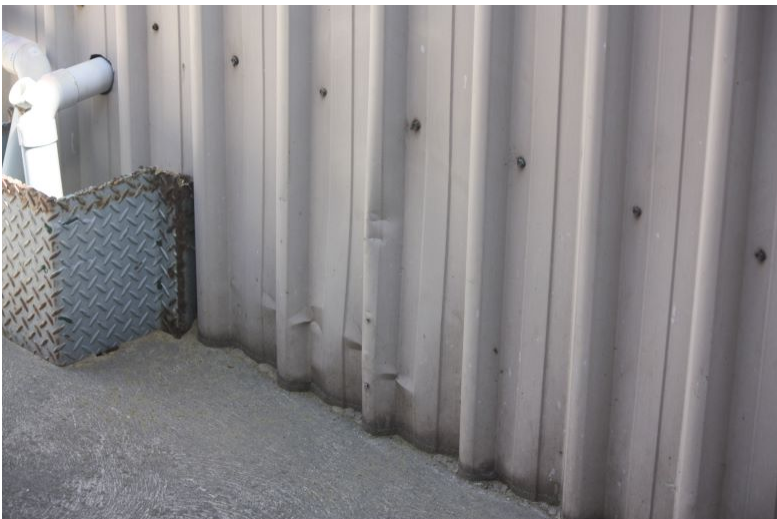
IMG_10033.JPG

View to metal cladding at bottom left corner of double doors at NW corner of factory.

Visible damage to cladding of wall and door. Cause unknown. Similar occurring to the east in this area.
