Dilapidation Report

Pre-Construction

PROPERTY: XX XXX Crescent
XXXXX Heights

JOB NUMBER: 222-0595-XXX-XX

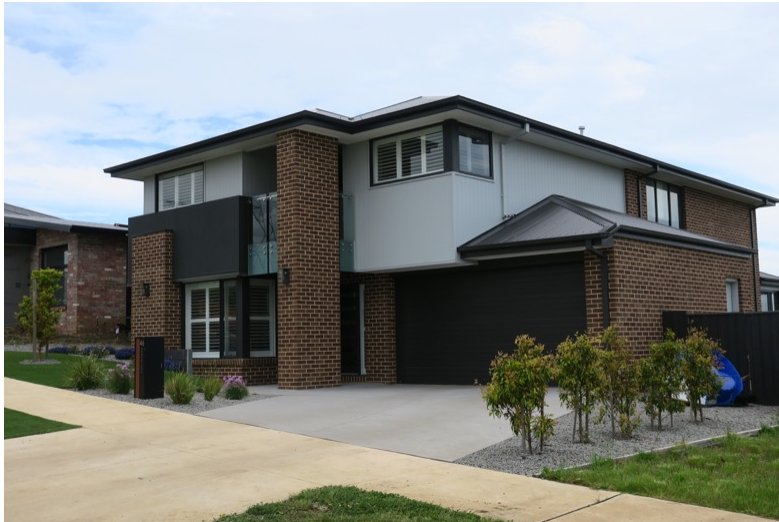
IMG_9110.JPG

View to front of property.
Photo for reference.

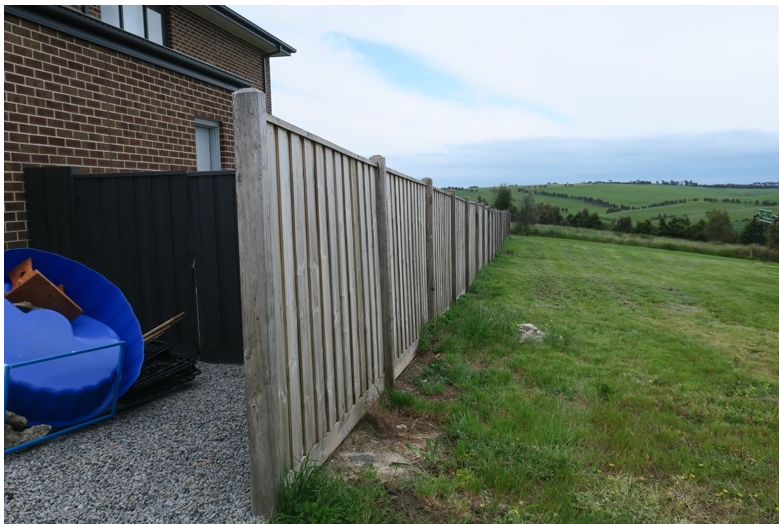
IMG_9111.JPG

View to fence along boundary.
Overall photo for reference. See additional photos.

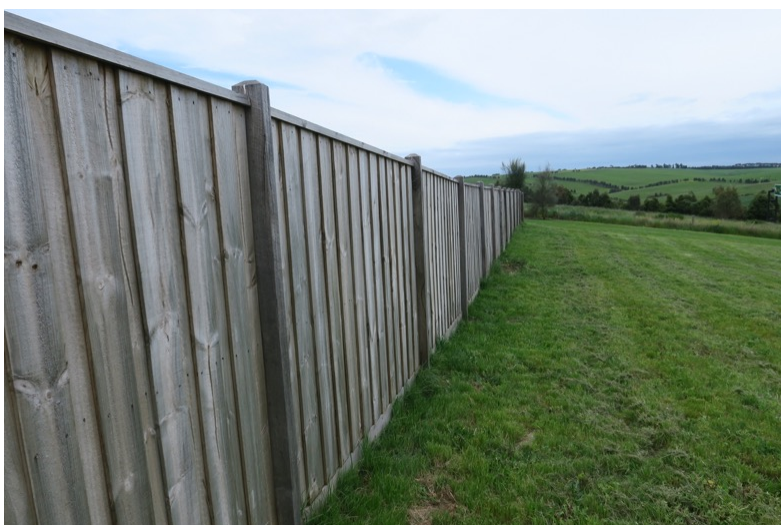
IMG_9115.JPG

View to fence NW of house.
Fence dips slightly.

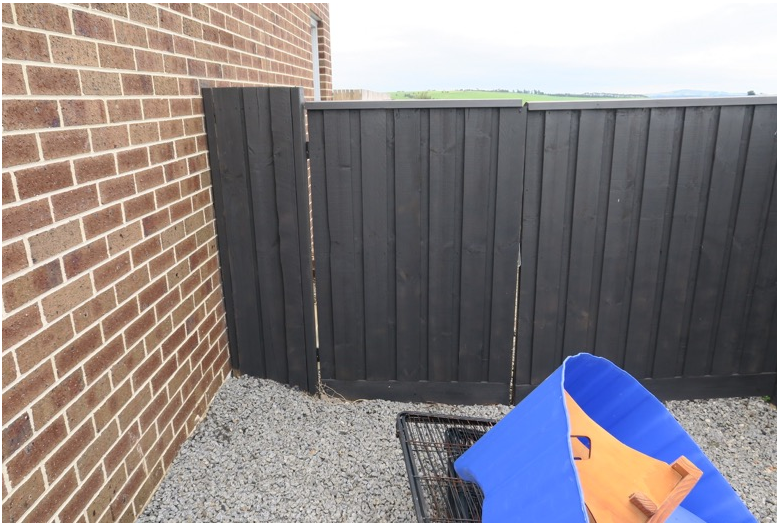
IMG_9129.JPG

View to side gate at top of gate.
Gate leans on fence.

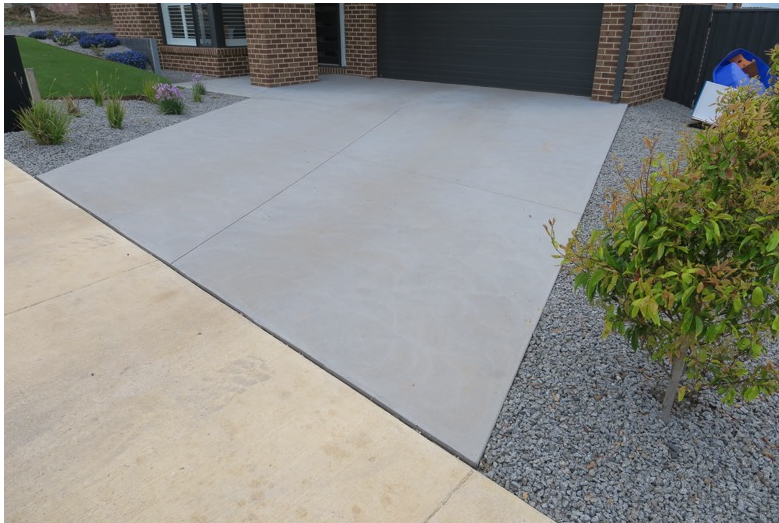
IMG_9131.JPG

View to driveway.

Overall photo for reference. No visible cracking.

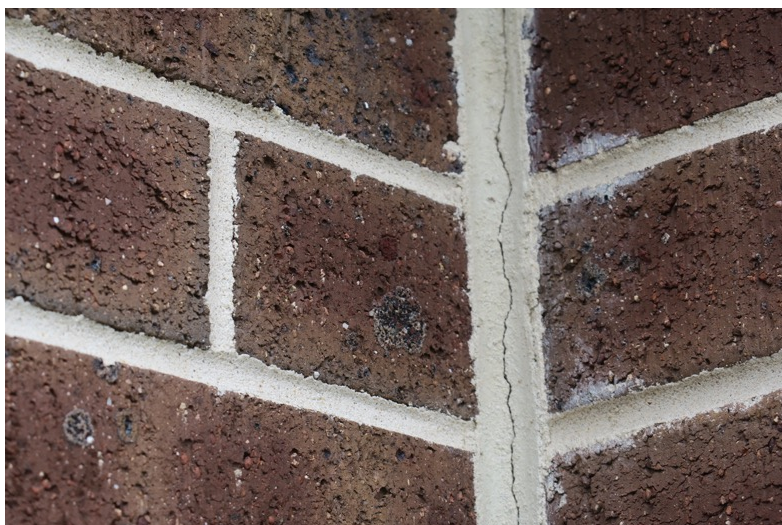
IMG_9137.JPG

View to house on SE corner at ground level.

Hairline crack to vertical joint.

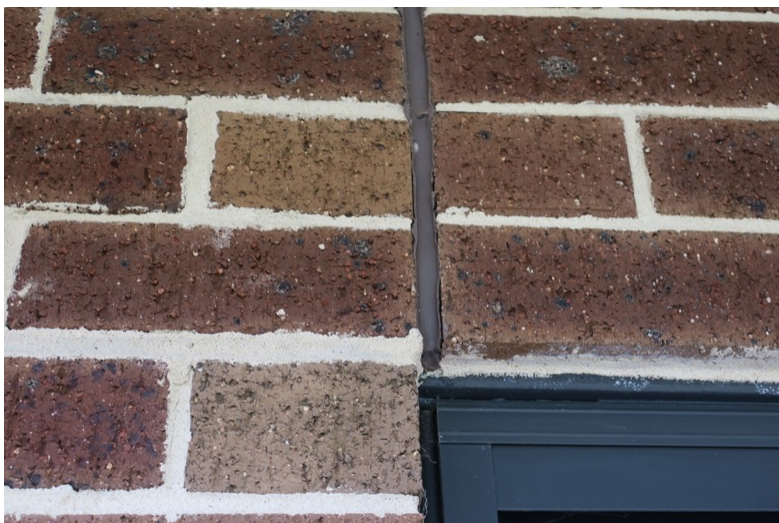
IMG_9142.JPG

View to brickwork top left of sliding doors
to house.

Light shrinkage of vertical caulking joint.

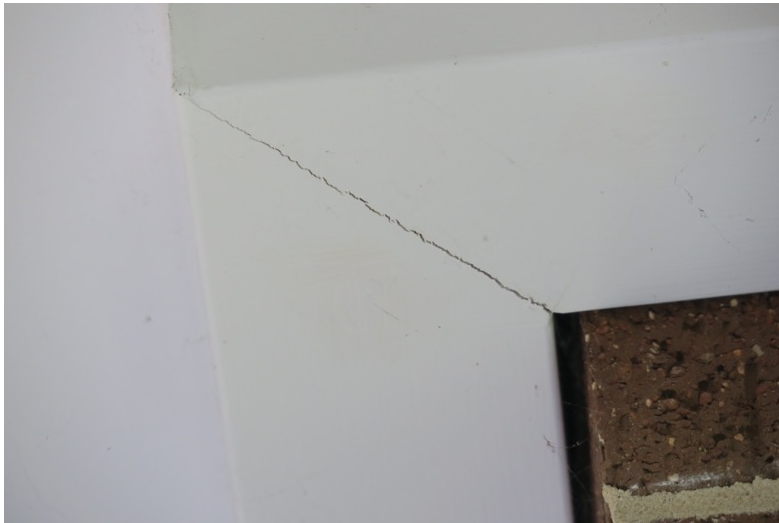
IMG_9143.JPG

View to cornice in NW corner.

Hairline separation of cornice mitre. Similar in SW corner.

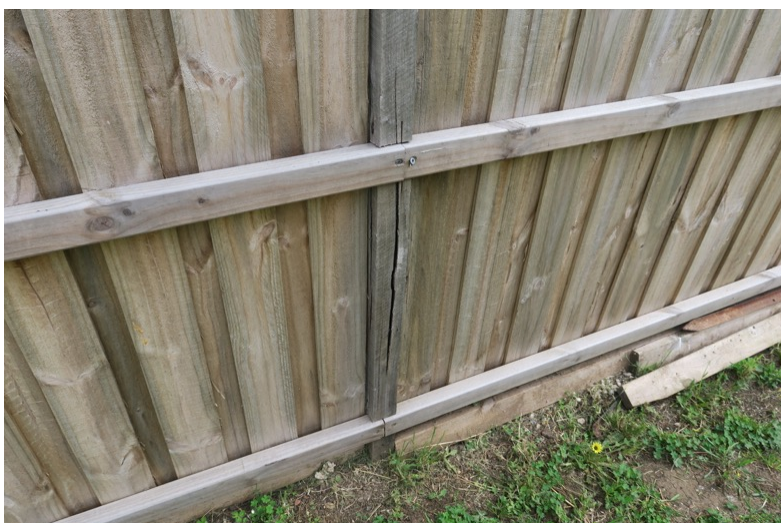
IMG_9148.JPG

View to fence post 4 west of north retaining wall.
Vertical split to timber post.

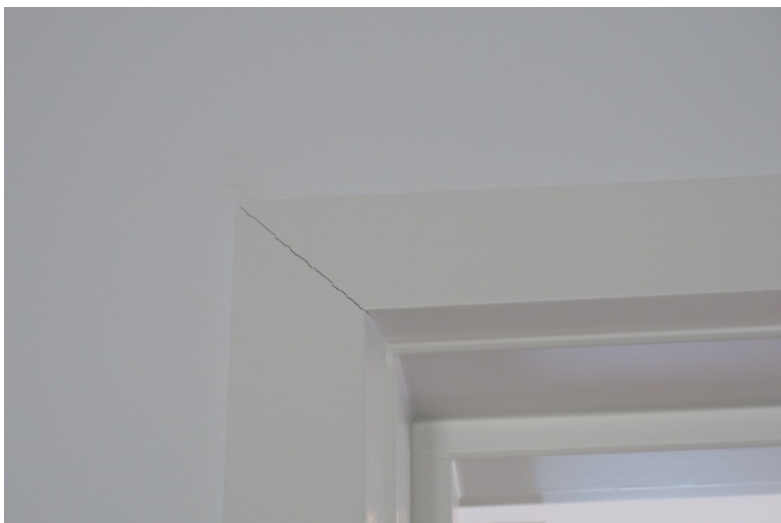
IMG_9156.JPG

View to architrave top left of door to living room.

Hairline separation of architrave mitre.

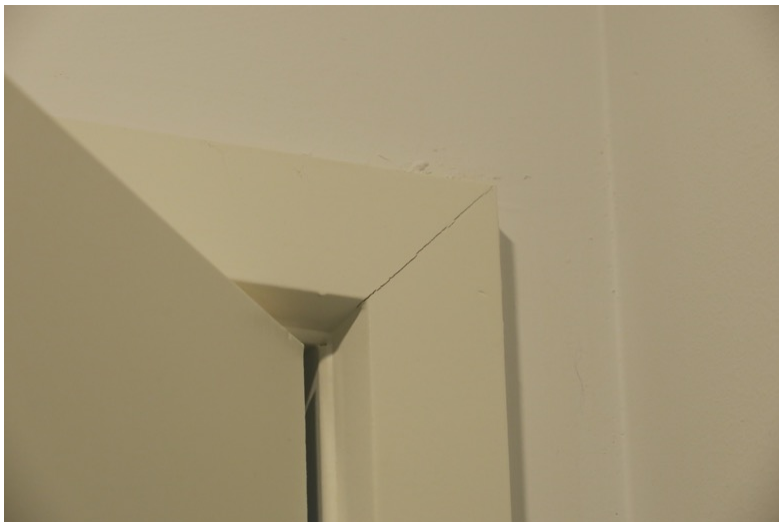
IMG_9158.JPG

View to architrave top right of door to front entry corridor.

Hairline separation of architrave mitre.
Similar elsewhere.

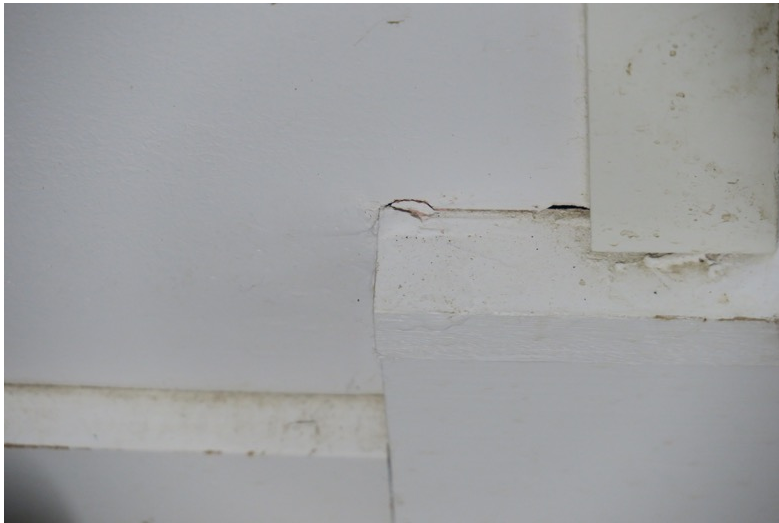
IMG_9160.JPG

View to skirting bottom left of door to house.

Hairline separation of skirting/wall.

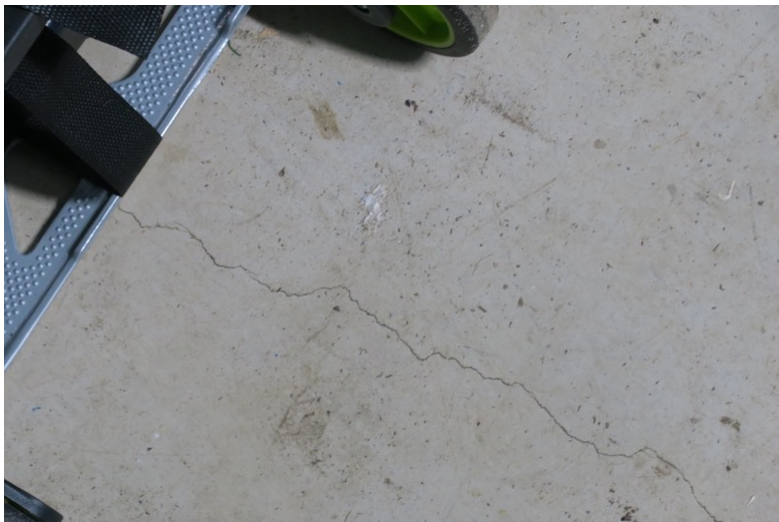
IMG_9161.JPG

View to concrete slab south of centre.

Hairline crack to concrete, extends north-south. Extent obscured by parked vehicle.

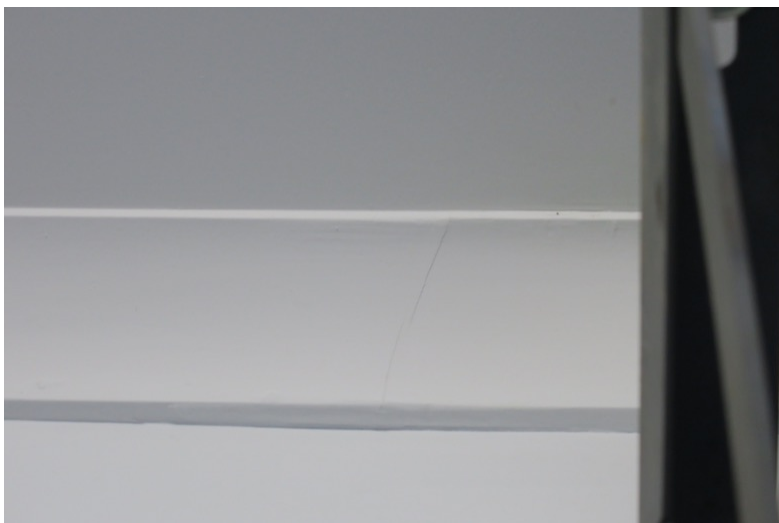
IMG_9162.JPG

View to cornice top left of west roller door.

Hairline separation of cornice joint.

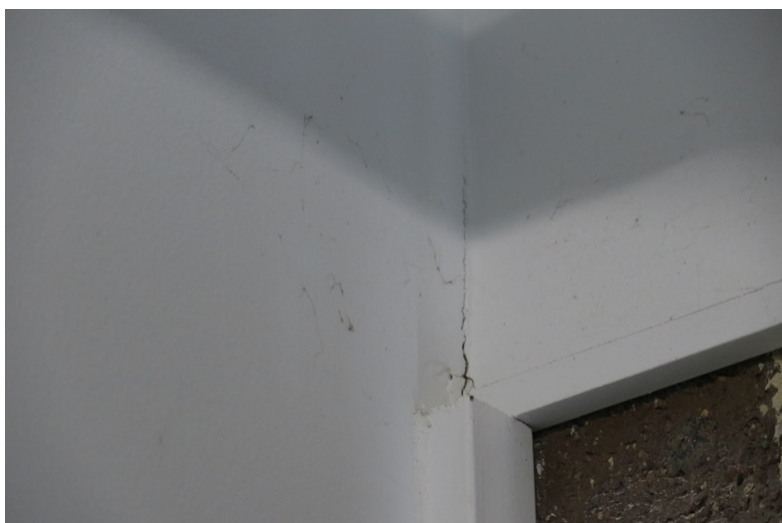
IMG_9164.JPG

View to wall in top NE corner.
Hairline crack to wall, extends up from
timber batten approx. 80mm.

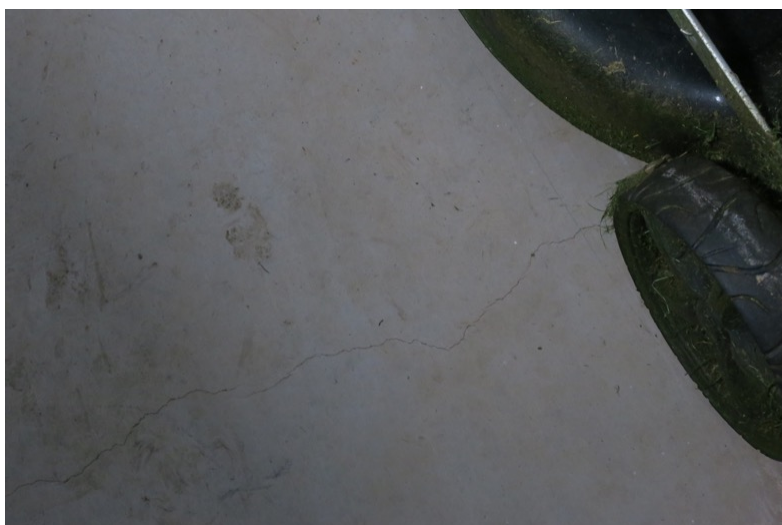
IMG_9165.JPG

View to north edge of slab below GPO.
Hairline crack, extends south. Possibly
connects to previously noted hairline crack.

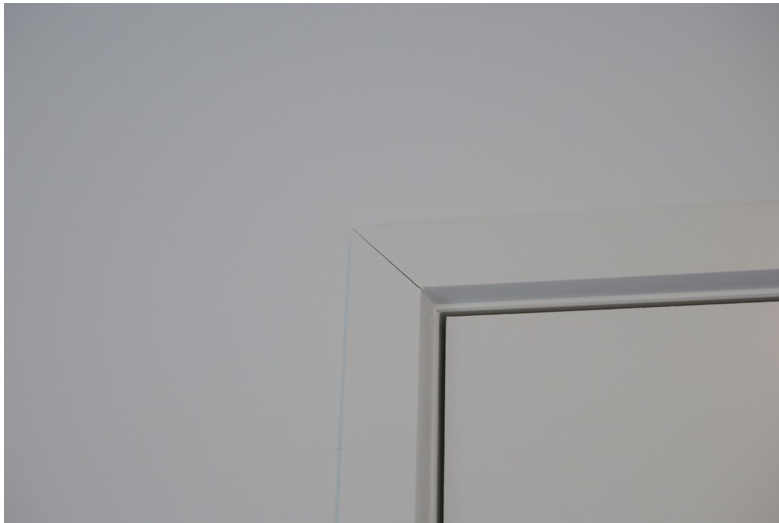
IMG_9166.JPG

View to architrave top left of door to front entry corridor.

Hairline separation of architrave mitre.

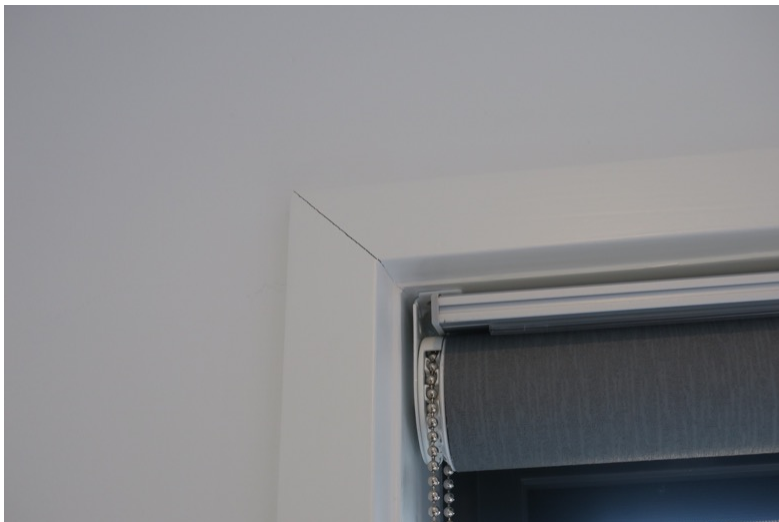
IMG_9167.JPG

View to architrave top left of RH north window.

Hairline separation of architrave mitre.

Similar elsewhere.

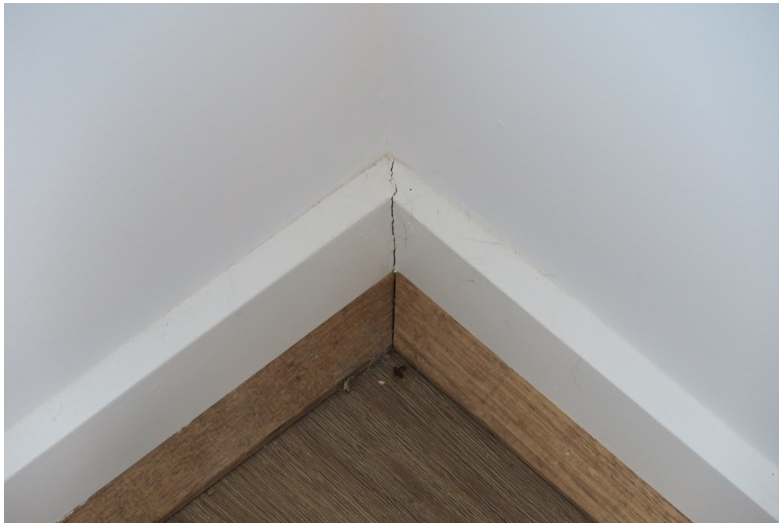
IMG_9169.JPG

View to skirting in NW corner.

Hairline separation of skirting mitre.

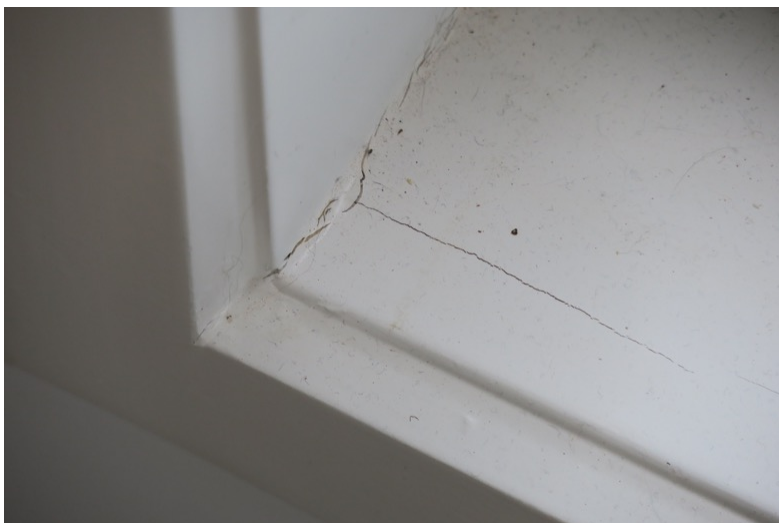
IMG_9171.JPG

View to sill bottom left of RH west window.

Hairline crack to paint over approx. 60mm.

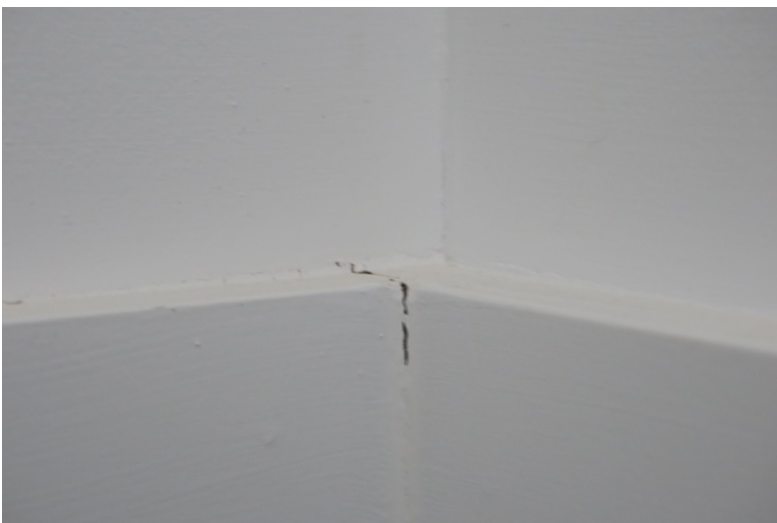
IMG_9174.JPG

View to timber band above SE corner of staircase.

Hairline separation of joint. Similar in SW corner. See additional photo.

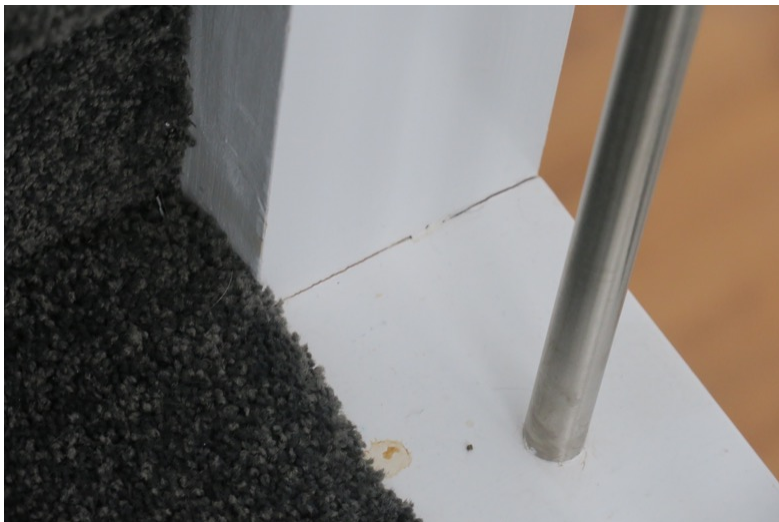
IMG_9176.JPG

View to top stair at balustrade.
Hairline separation of post/tread.

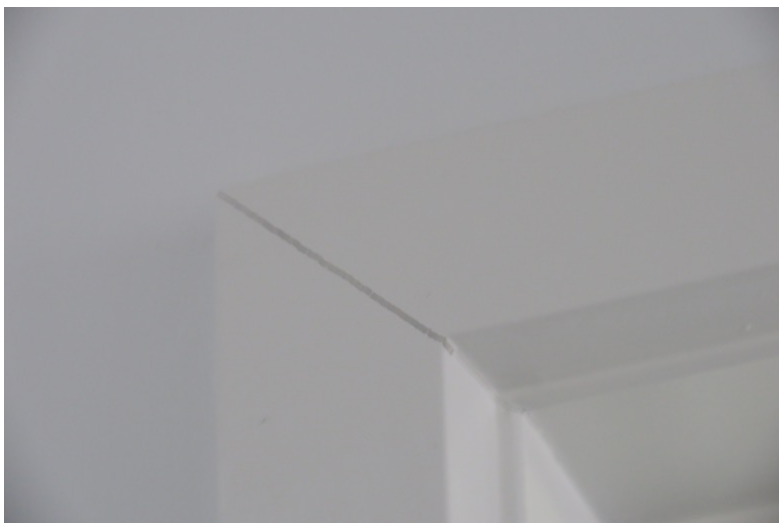
IMG_9177.JPG

View to architrave top left of door to east bedroom.

Hairline separation of architrave mitre.

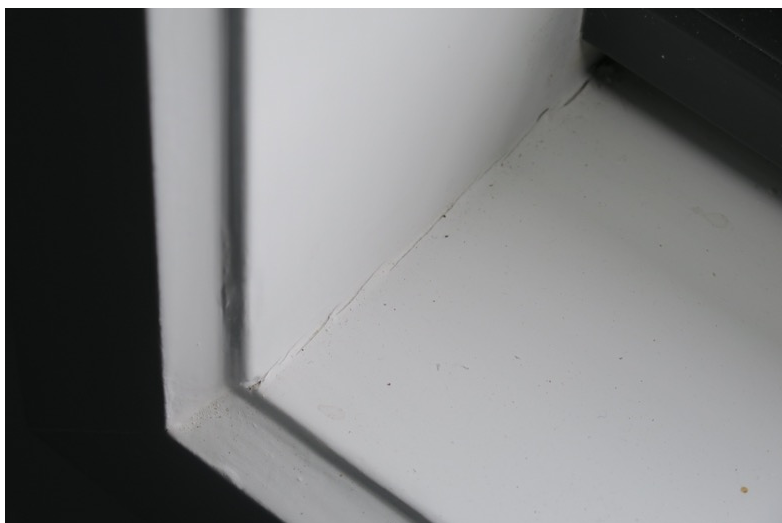
IMG_9178.JPG

View to sill bottom left of window.
Hairline separation of sill/reveal.

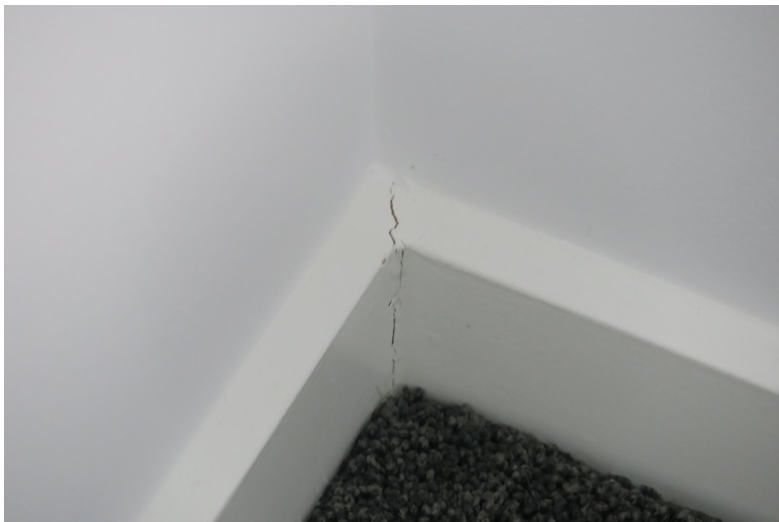
IMG_9182.JPG

View to skirting in NE corner.

Hairline separation of skirting mitre. Similar elsewhere.

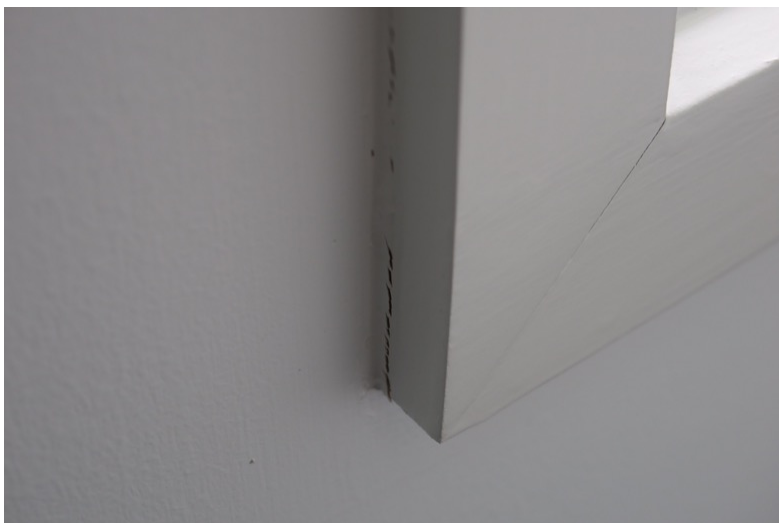
IMG_9183.JPG

View to architrave bottom left of window.

Hairline separation of architrave/wall, extends intermittently over approx. 80mm.

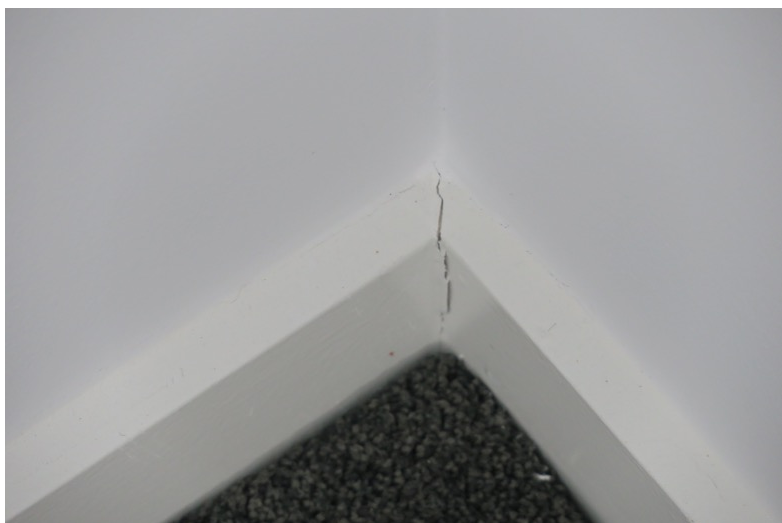
IMG_9184.JPG

View to skirting in SW corner.

Separation of skirting mitre. Approx. 1mm maximum.

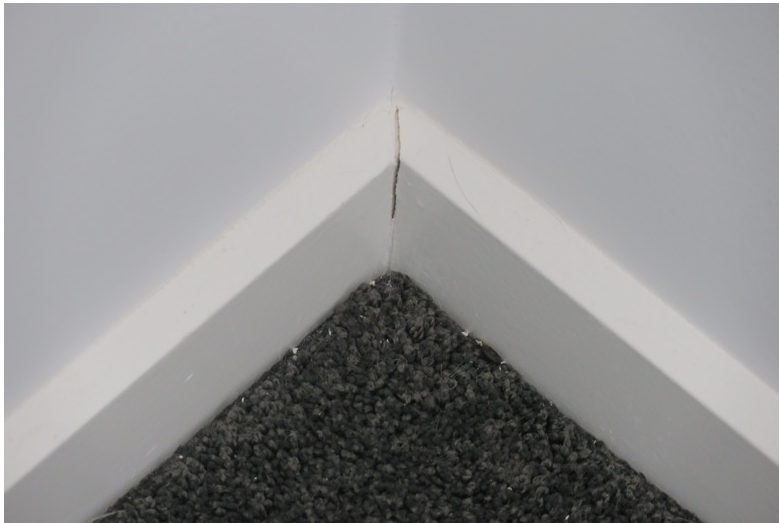
IMG_9187.JPG

View to skirting in NE corner.

Hairline separation of skirting mitre.
