# SAMPLE REPORT

## EXISTING CONDITIONS (DILAPIDATION) REPORT- Residential

**Address:** No Street  
Suburb

**SCHEDULE - EXISTING CONDITIONS SURVEY**  
*No Street Suburb*

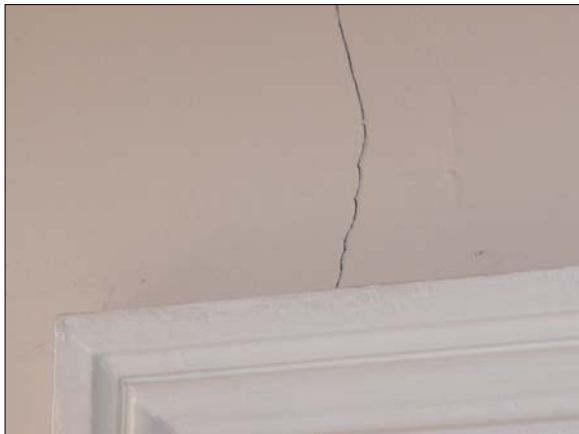
P1080361  
13/03/2008 9:18:42 AM

<b>P108 0359</b>	Front hallway – view to north wall.	Skirting has been removed from wall. Note this applies to all skirtings in the front and rear sections of the hall and the front bedroom.
<b>P108 0360</b>	Front hallway – view to archway at western end of front hall.	Crack through head of arch extends across plaster wall to north wall on both sides of arch. Approx. 1mm maximum.
<b>P108 0361</b>	Front hallway – view to south wall top left hand corner of door to front bedroom.	Crack extending vertically up wall from architrave approx. 400mm where the crack splits into two other cracks extending to within 200mm of cornice. Approx. 1mm maximum. Note architraves at top left hand corner of door have separation crack. Approx. 1mm maximum.
<b>P108 0362</b>	Rear hallway – view to ceiling at north west corner.	Crack through corner of ceiling and at ceiling/cornice junction extending full width across western end of hall and ¾ of the length of the north wall. Approx. 1-2mm.

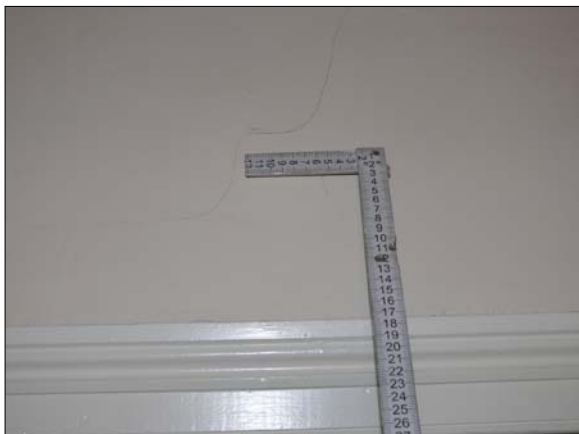
P1080363  
13/03/2008 9:23:40 AM

<b>P108 0363</b>	Rear hallway – view to west wall above door head.	Crack in plaster commencing approx. 100mm above centre of door head and extending at approx. 45° to north west corner finishing approx. 300mm below cornice level. 1mm maximum.

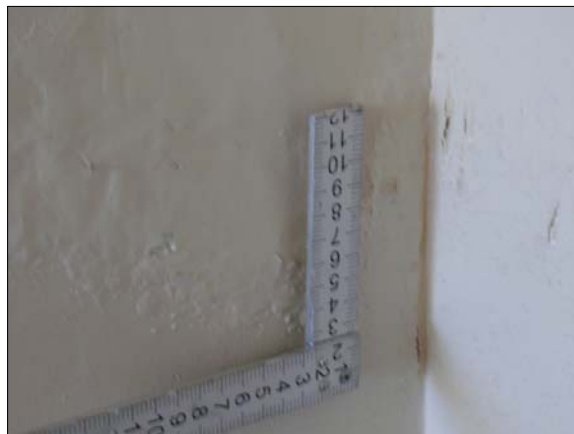
P1080365  
13/03/2008 9:27:36 AM

<b>INTERIOR</b>		
<b>Photo No.</b>	<b>Photo Location and Direction</b>	<b>Comment</b>
<b>P108 0365</b>	Rear hallway – view to south west corner approx. 600mm above floor level.	Water damage to plaster on south wall extending approx. 400mm from corner and on west wall extending across to door architrave.
<b>P108 0366</b>	Rear hallway – view to south wall on right hand side of door to Bedroom Two.	Water damage at approx. 600mm above floor level extending over an area approx. 600mm x 400mm.
<b>P108 0367</b>	Rear hallway – view to top right hand corner of door to Bedroom Two.	Hairline crack extending from corner of architrave at approx. 45° and extending for approx. 400mm.
<b>P108 0368</b>	Rear hallway – view to south wall between door to Bedroom Two and south west corner.	A number of hairline cracks occur in this area of wall extending from approx. 1600mm above floor up to within 300mm of cornice. 1mm maximum.
