Dilapidation Report

Pre-Construction

PROPERTY: STREET
SUBURB

JOB NUMBER: 222-XXX-XXX

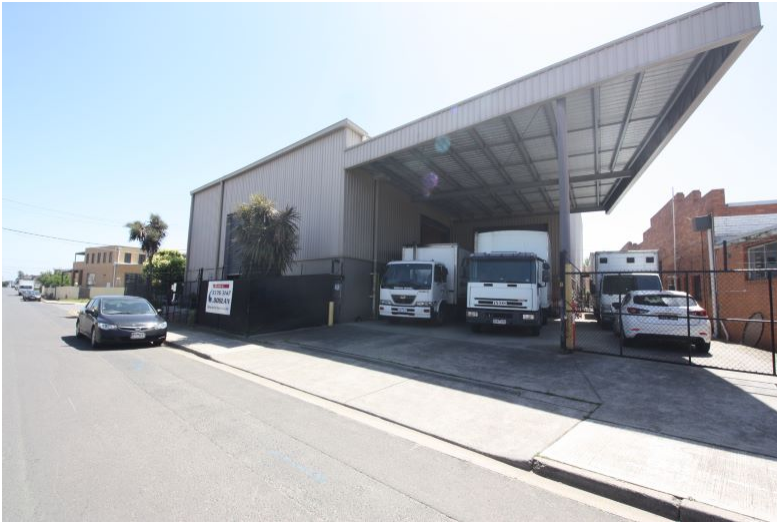
IMG_09980.JPG

FRONT OF PROPERTY

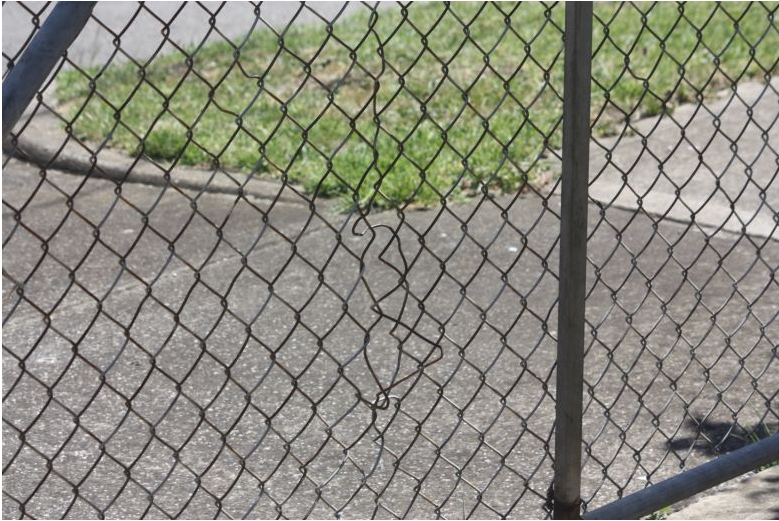
IMG_10008.JPG

Gate generally in fair condition. Some areas of damage visible to mesh with rust in areas.

Further photo of above.

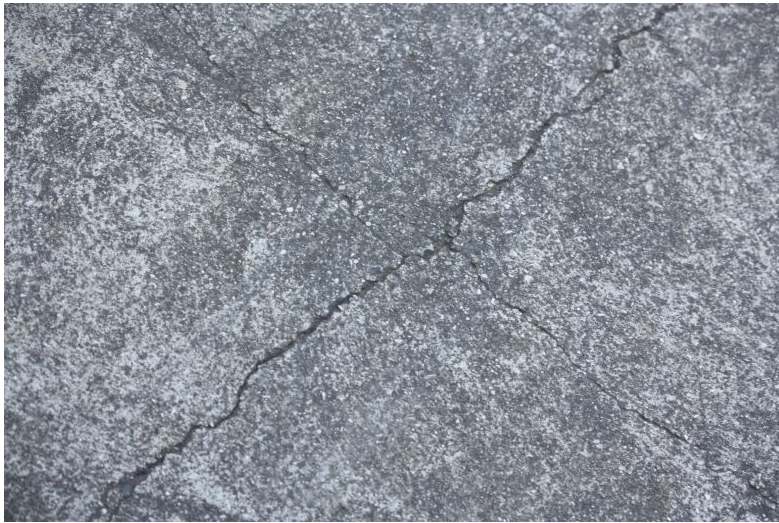
IMG_10021.JPG

Visible cracking running east to west to full width of concrete panel, hairline to 2mm. Cracking also spreads out south. See additional photo.

Further photo of above.
