Dilapidation Report

Pre-Construction

PROPERTY: XX XXX Crescent
XXXXX Heights

JOB NUMBER: 222-0595-XXX-XX

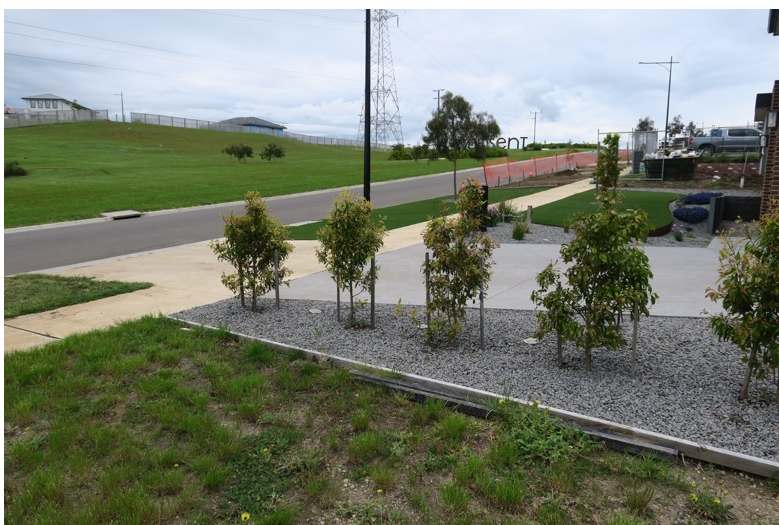
IMG_9112.JPG

Further photo of above.

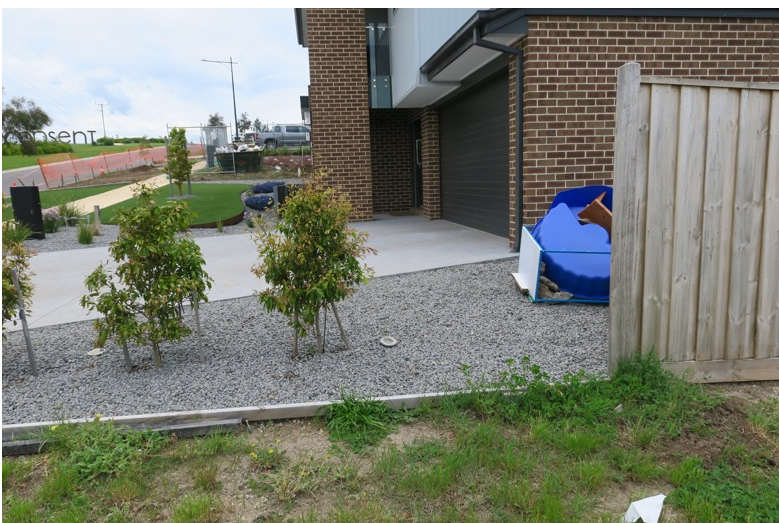
IMG_9113.JPG

Further photo of above.

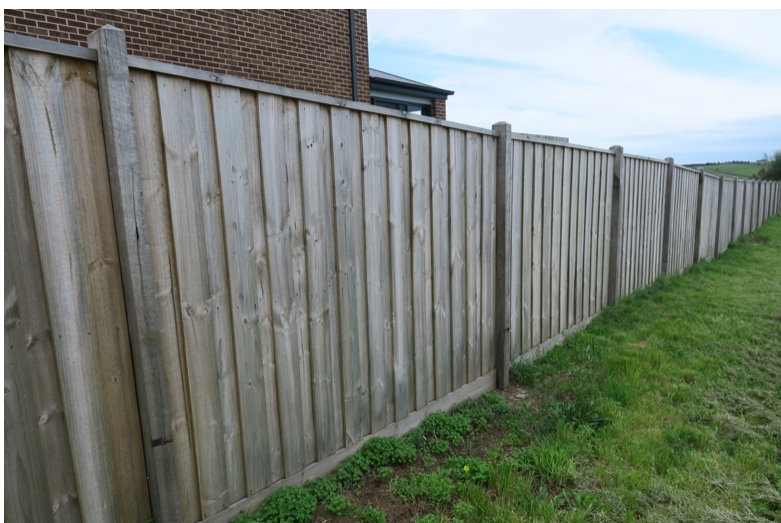
IMG_9114.JPG

Further photo of above.

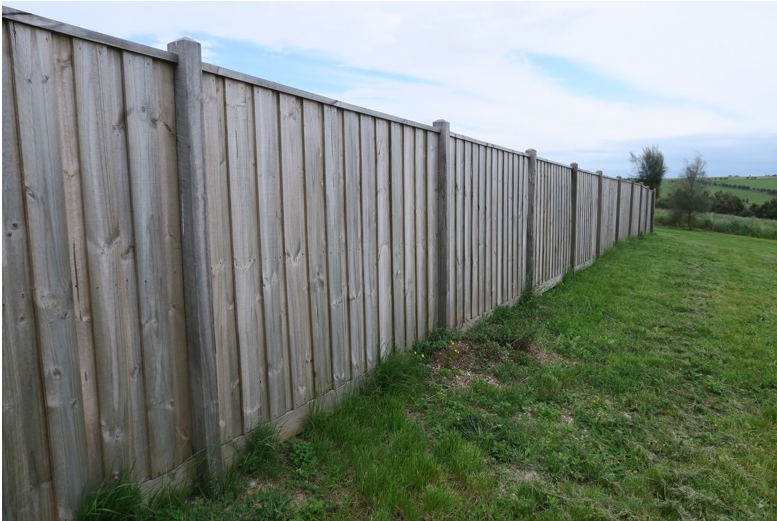
IMG_9117.JPG

View to fence west of last.
Note soil gap between bottom of
fence/ground level over 2 panels.

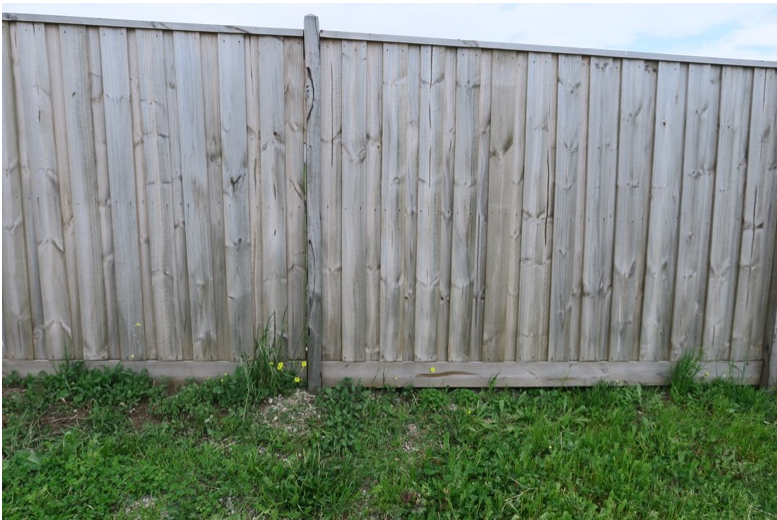
IMG_9118.JPG

**View to fence towards west end of
property.**
Overall photo for reference.

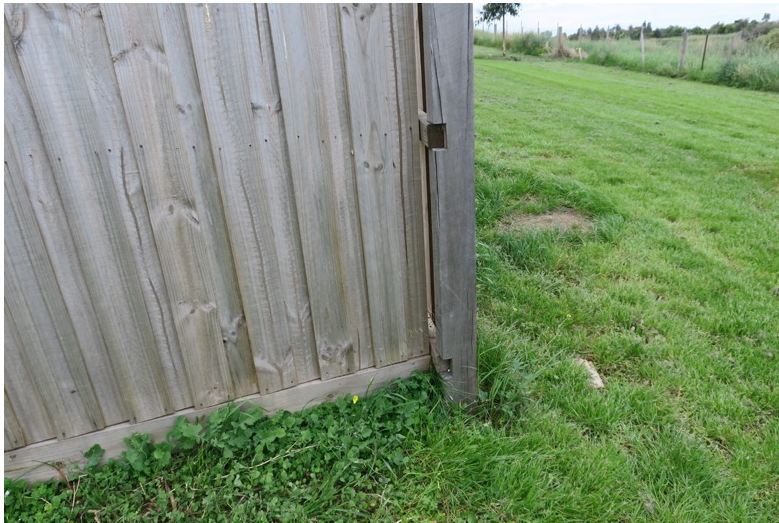
IMG_9119.JPG

View to fence on NW corner of property.
Overall photo for reference. See additional photo.

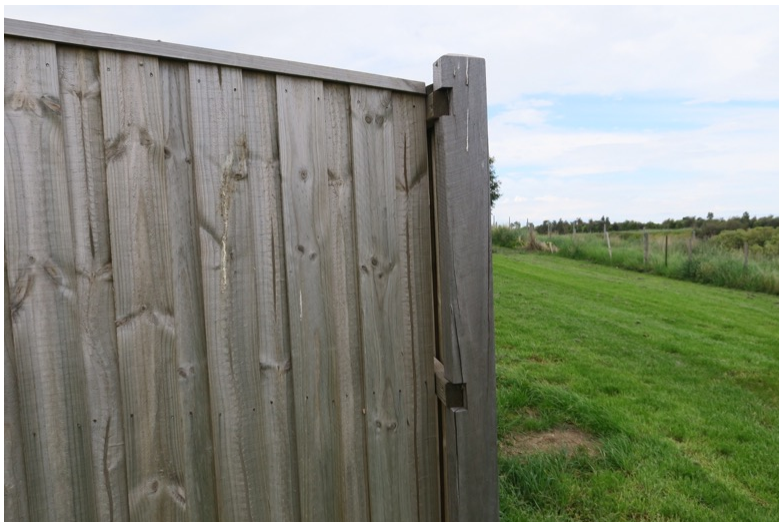
IMG_9120.JPG

Further photo of above.

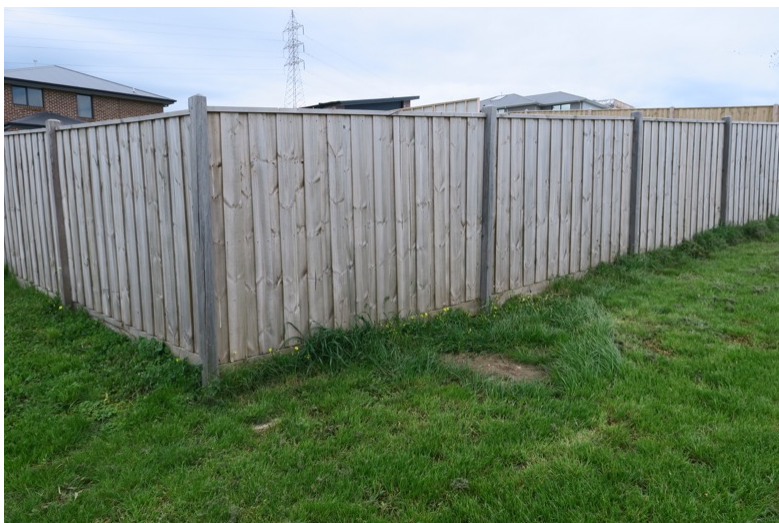
IMG_9121.JPG

View to fence on west end of property.
Overall photo for reference. See additional photo.

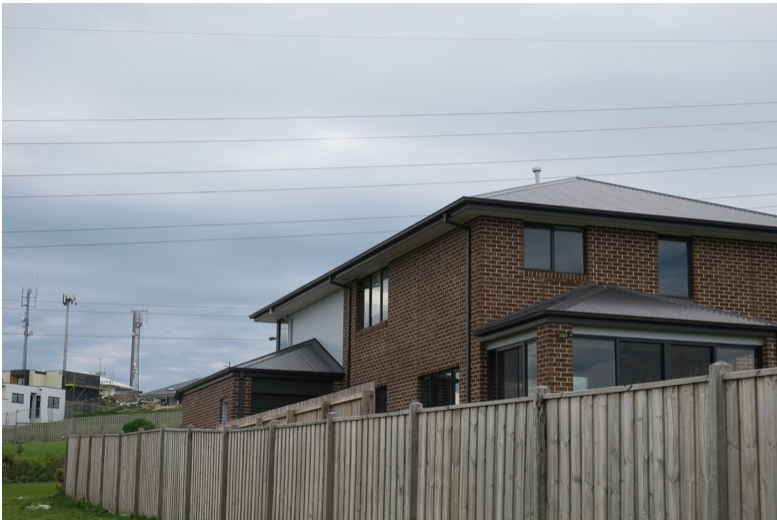
IMG_9124.JPG

Further photo of above.

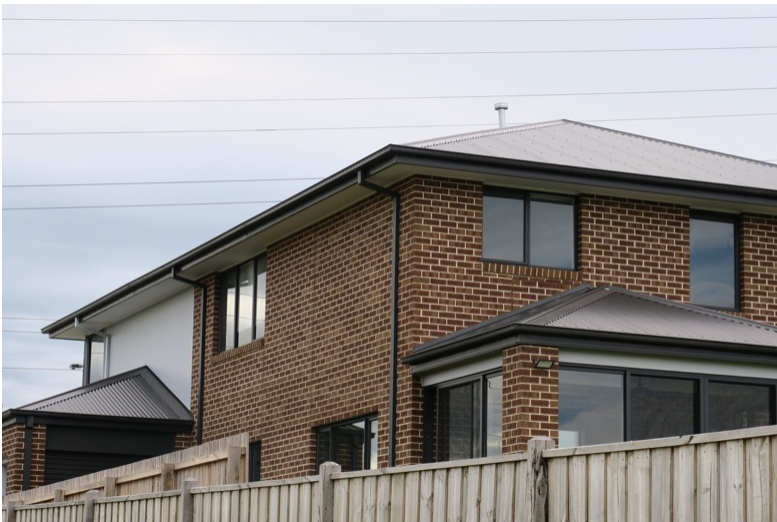
IMG_9125.JPG

Further photo of above.

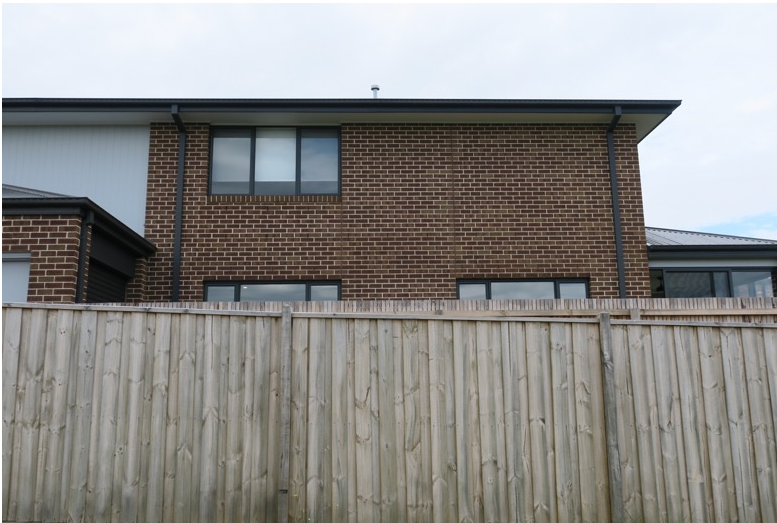
IMG_9126.JPG

Further photo of above.

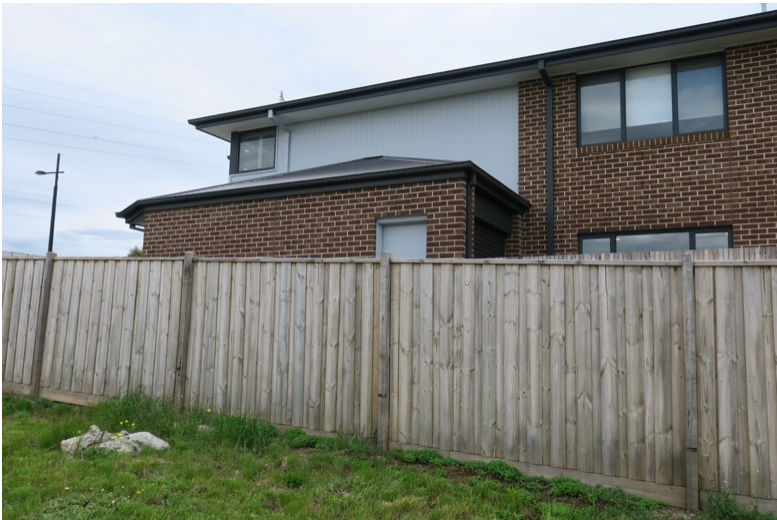
IMG_9127.JPG

View to side fence north of garage.

Overall photo for reference. See additional photo.

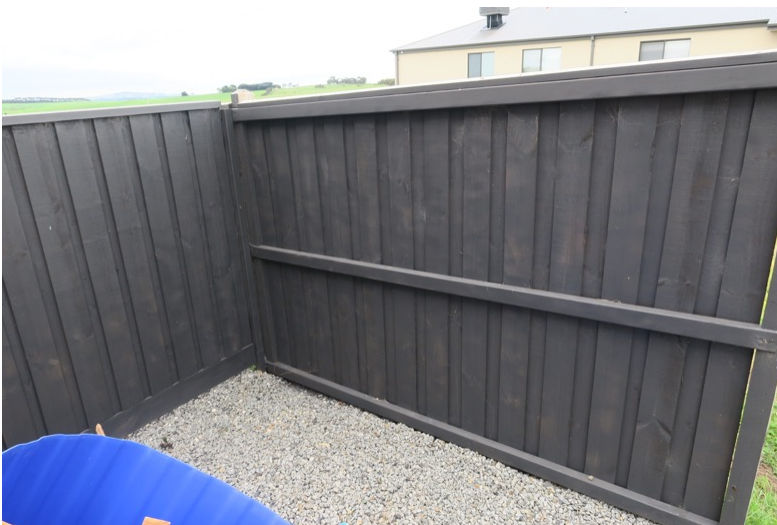
IMG_9128.JPG

Further photo of above.

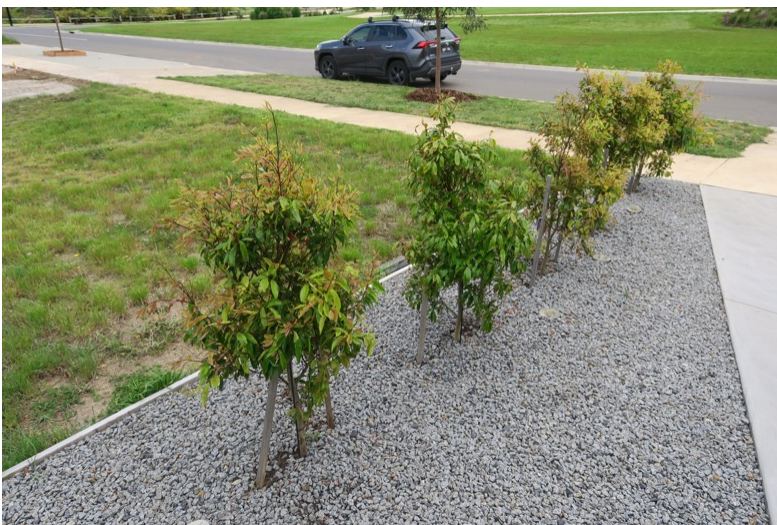
IMG_9131.JPG

View to driveway.

Overall photo for reference. No visible cracking.

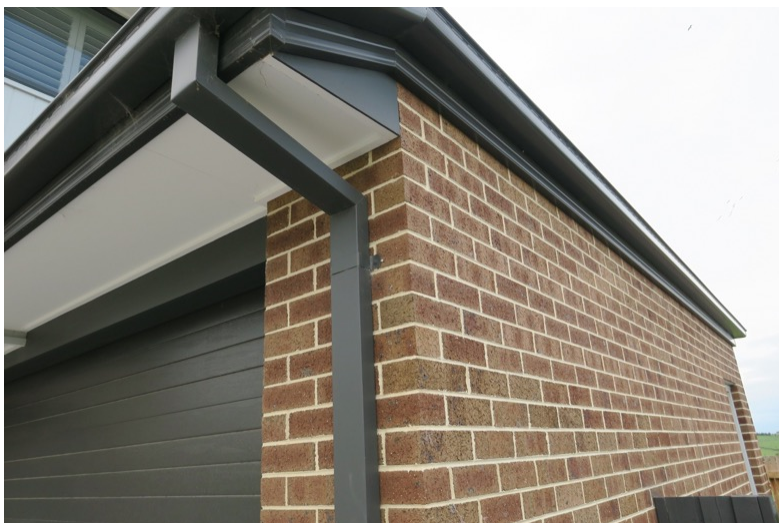
IMG_9133.JPG

Further photo of above.

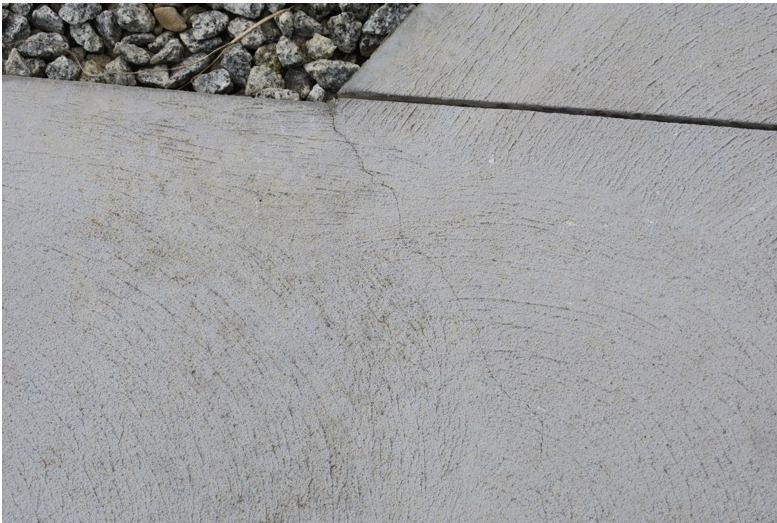
IMG_9134.JPG

View to driveway NE of front entry brick pier.

Hairline crack, extends west approx. 400mm.

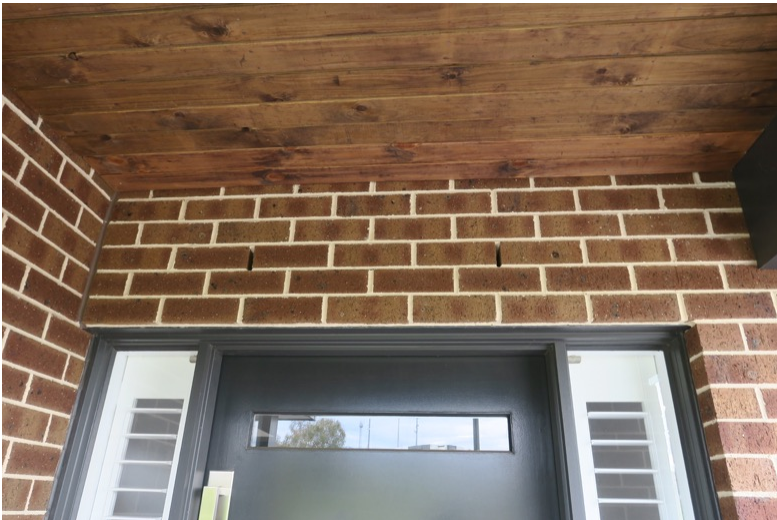
IMG_9135.JPG

View to brickwork above front door.

Photo for reference. No visible defect.

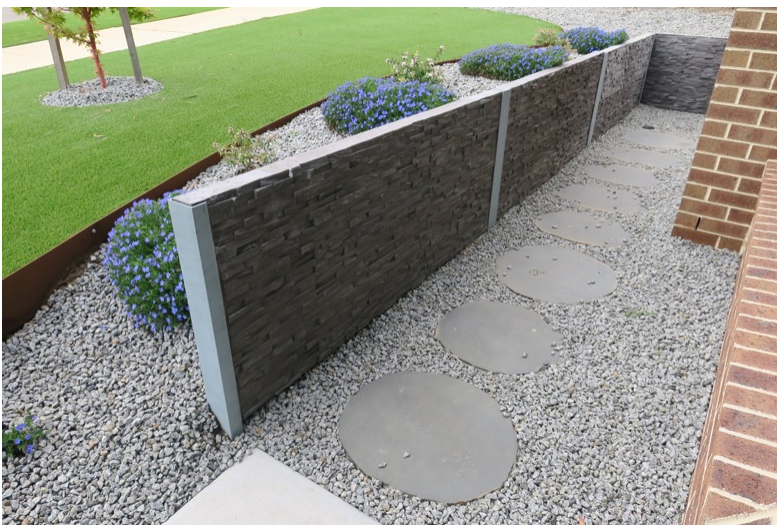
IMG_9136.JPG

View to retaining wall east of house.

Photo for reference. No visible defect.

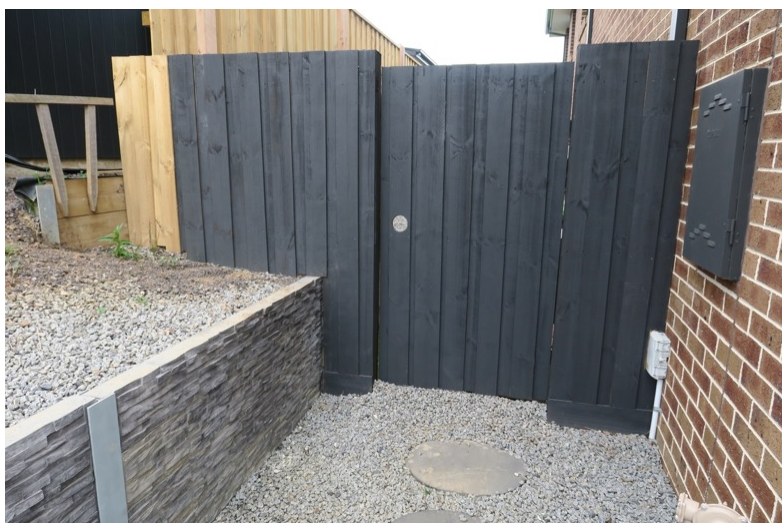
IMG_9138.JPG

View to south side gate.

Overall photo for reference. No visible defect.

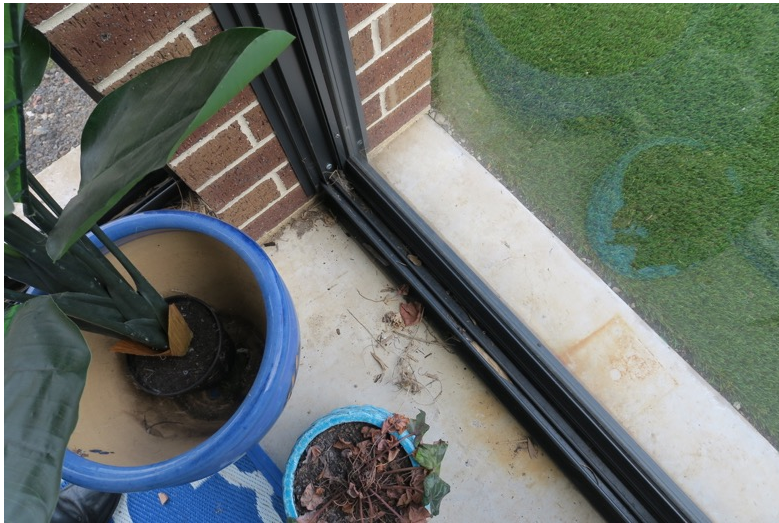
IMG_9140.JPG

WEST ELEVATION AND SURROUND
View to concrete slab on internal NW
corner of alfresco area.

Photo for reference. No visible defect.

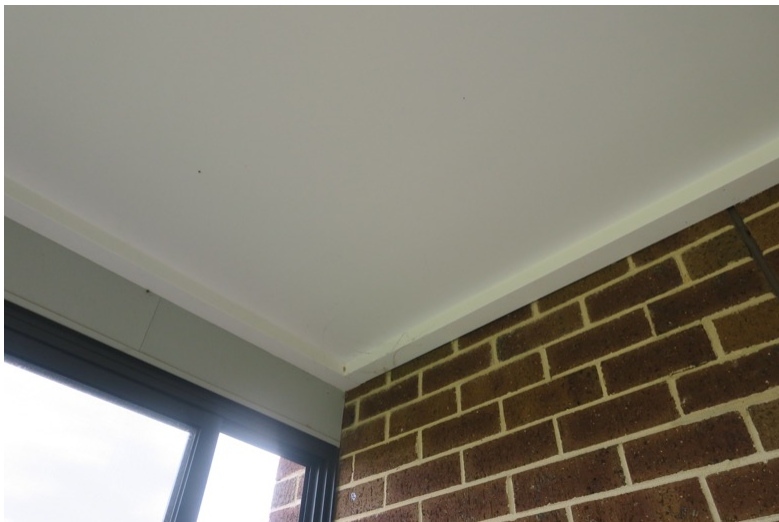
IMG_9141.JPG

View to brickwork and ceiling in NE corner
of alfresco area.

Photo for reference. No visible defect.

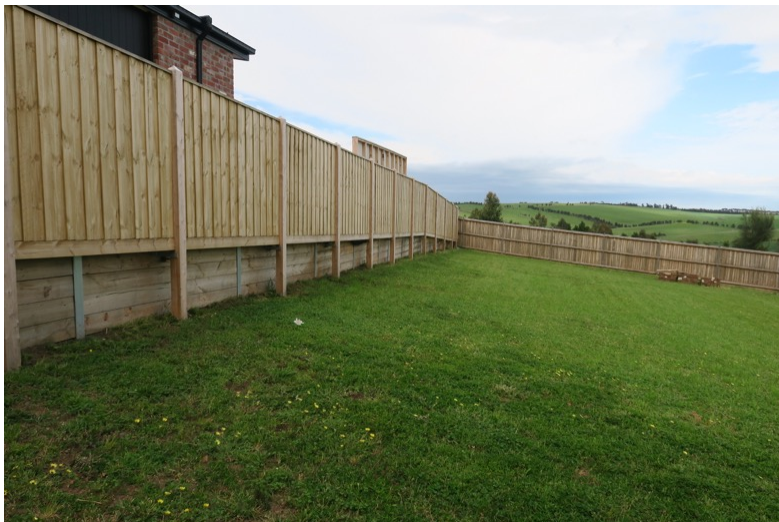
IMG_9144.JPG

View to west end of property.

Overall photo for reference. See additional photo.

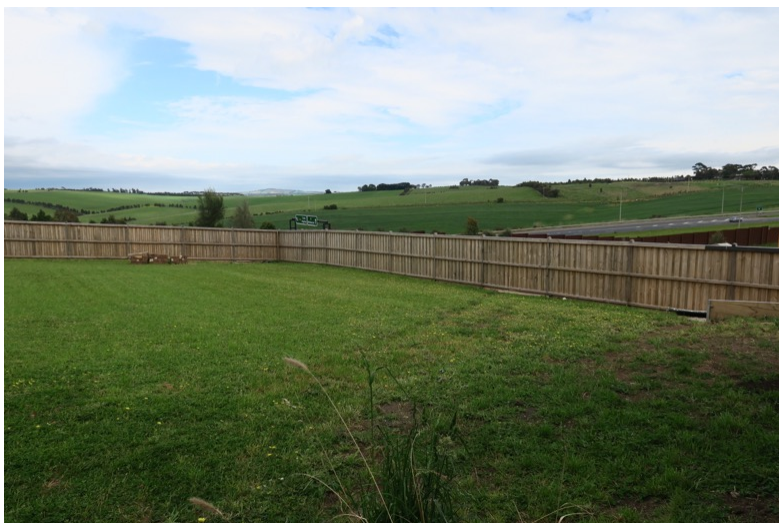
IMG_9145.JPG

Further photo of above.

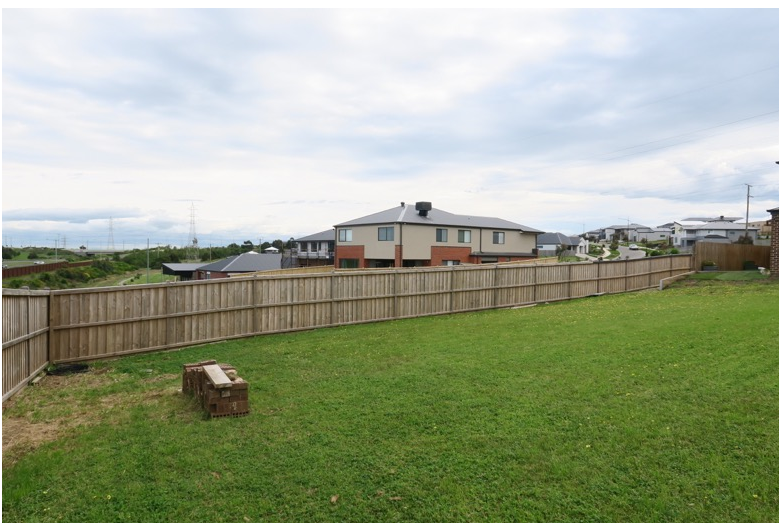
IMG_9147.JPG

View to north boundary fence.
Overall photo for reference.

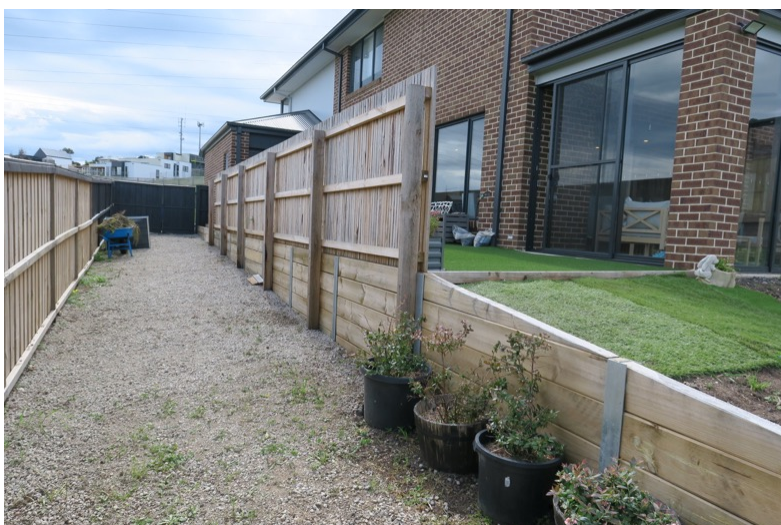
IMG_9149.JPG

View to retaining wall and screening north of house.
Overall photo for reference. No visible defect.

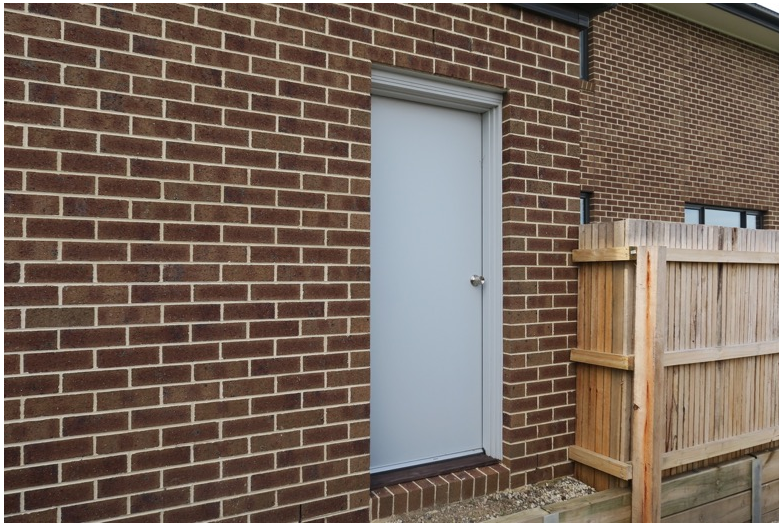
IMG_9150.JPG

View to door to garage.

Overall photo for reference. No visible defect.

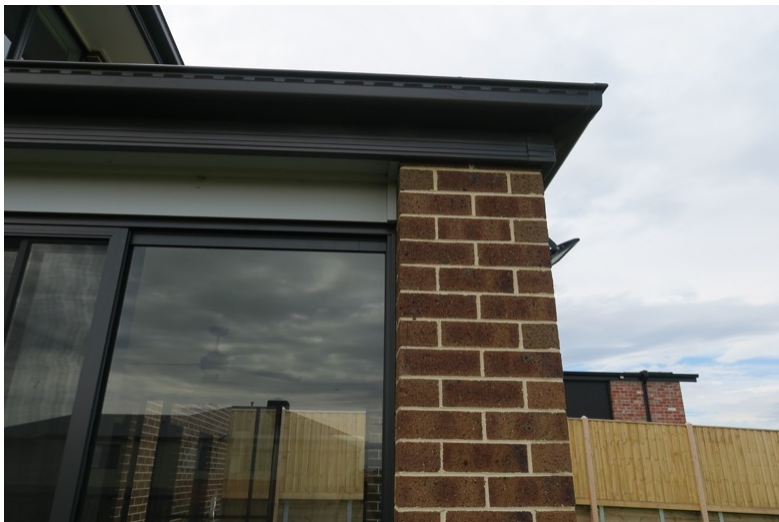
IMG_9151.JPG

View to north elevation of alfresco area.

Overall photo for reference. No visible defect.

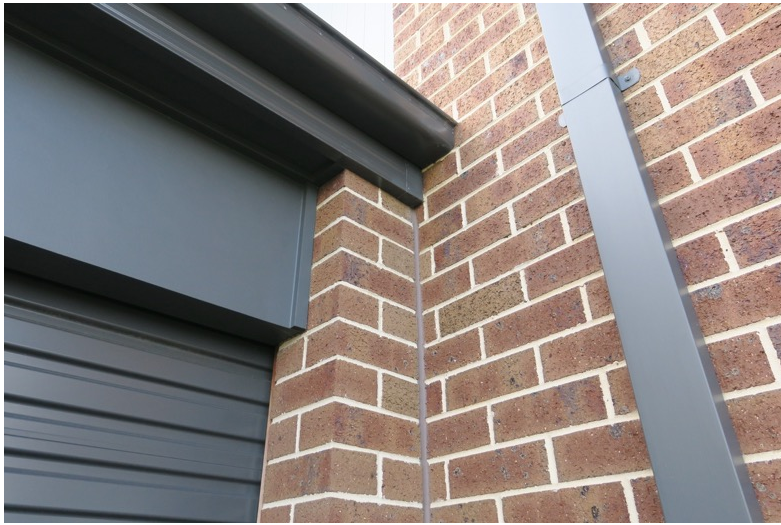
IMG_9153.JPG

View to brickwork top right of west facing garage door.

Photo for reference. No visible defect.

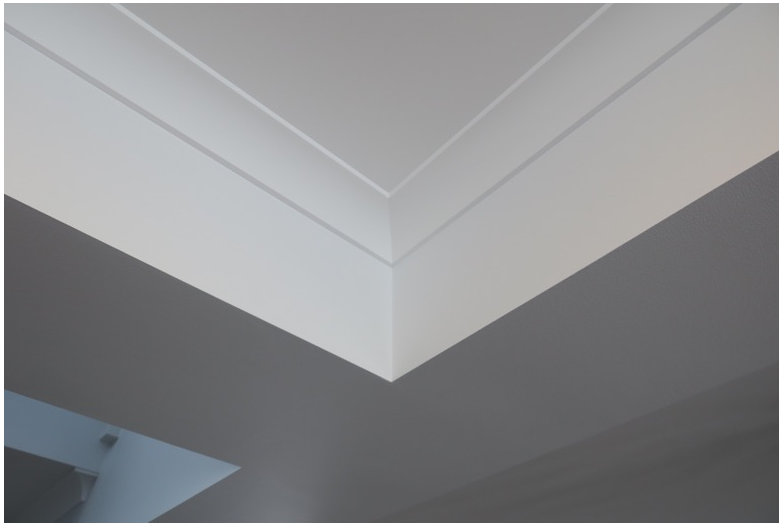
IMG_9157.JPG

Photo for reference. No visible defect.

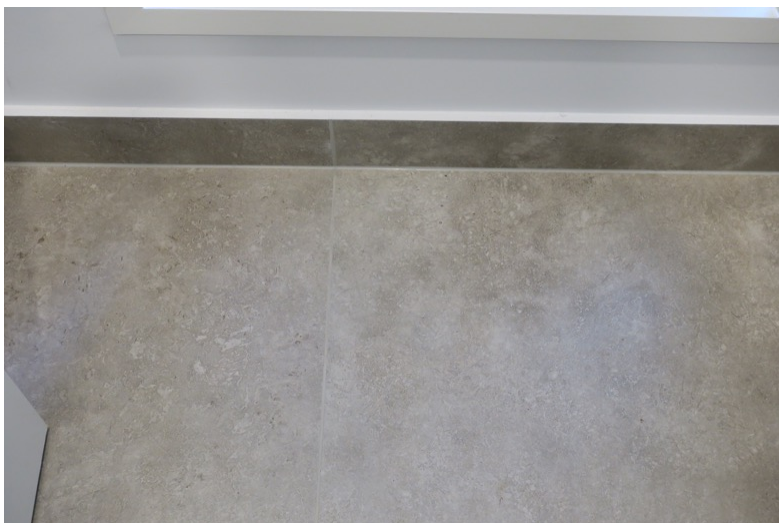
IMG_9159.JPG

View to floor tiles below window in toilet.

Overall photo for reference. No visible defect.
